# Construction Failures and Innovative Retrofitting

Nicola Augenti <sup>1</sup>, Antonio Nanni <sup>1,2,\*</sup> and Fulvio Parisi <sup>1</sup>

**Abstract:** The aim of this paper is twofold: (a) to briefly describe the damage caused to historical, residential and industrial buildings by the May 2012 seismic events in the Emilia Romagna region of Italy; and (b) to summarize novel repair and rehabilitation technologies that can be available to practitioners to fix damaged structures or to upgrade undamaged ones. Field inspections after the Emilia Romagna earthquakes showed that seismic vulnerability in that region was primarily due to the lack of seismic detailing in modern buildings, and the presence of heavy nonstructural masses in historical buildings. The novel retrofit technologies discussed in this paper are based on the use of non-conventional or relatively recent material systems where the reinforcement is in the form of continuous or chopped fibers.

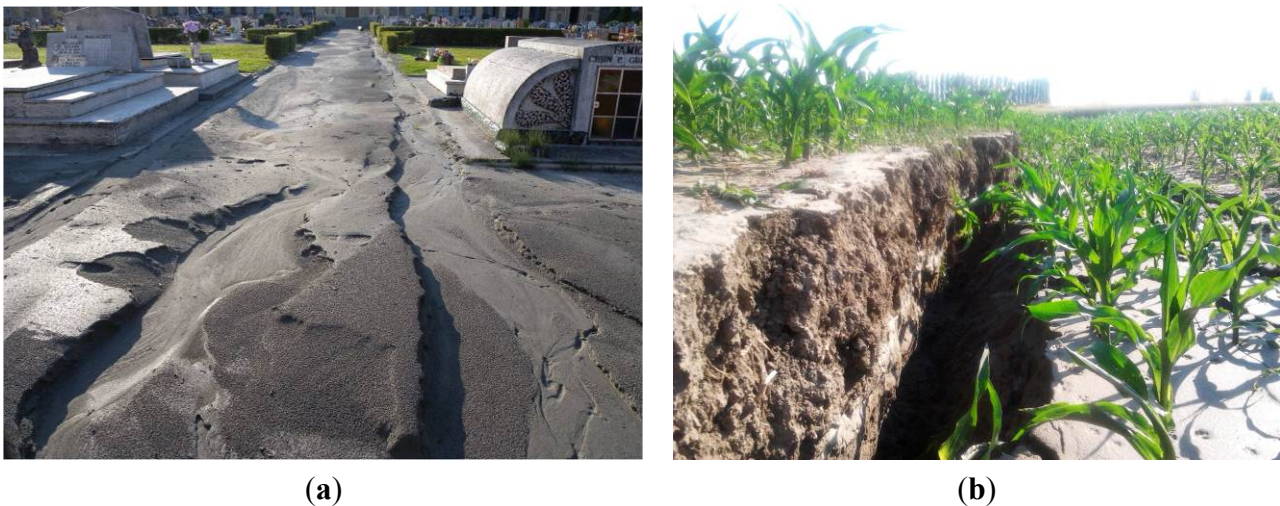
The area affected by the 20–29 May 2012, earthquakes is located in the Emilian river Po valley, between Modena and Ferrara, and is characterized by unconsolidated soil layers which can induce local amplifications of earthquake ground motion. The Emilian river Po valley is a rather flat alluvial plane which has experienced many floods from several tributary rivers of the Po and Reno rivers in the past. The ground is mainly composed of alternated fine sand and clay layers that caused soil liquefaction phenomena and the formation of sand volcanoes (Figure 2a) in a number of villages (such as Mirabello, Sant’Agostino, Cavezzo and San Felice sul Panaro) during the 2012 Emilia Romagna earthquakes. Soil liquefaction at San Carlo, a fraction of Sant’Agostino, caused surface fractures with a maximum width of 1.05 m and a vertical relative displacement of up to 1.90 m (Figure 2b). Liquefaction-induced differential settlements and lateral spreading of ground were a common cause of collapse in buildings.

**Figure 2.** Soil liquefaction effects: (a) Sand volcano in a cemetery; (b) Surface fracture.

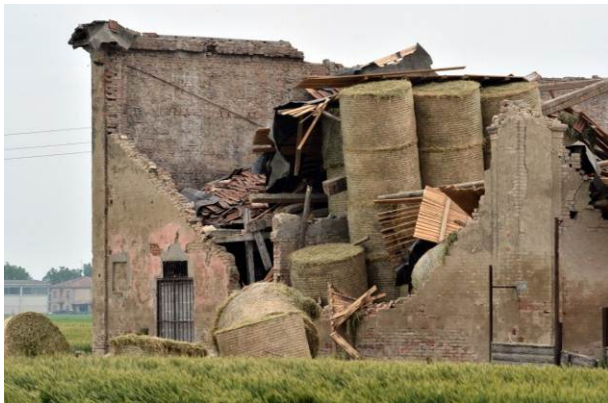
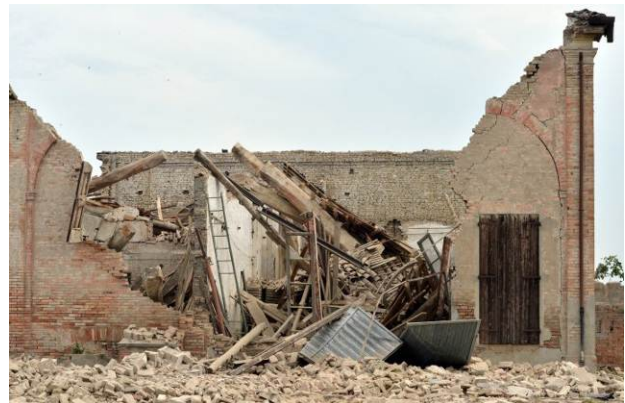
About 100 rural clay brick masonry buildings consisting of dwellings and haylofts were strongly damaged or collapsed (Figure 3a,b). Many rural buildings suffered out-of-plane wall failures, tilting of masonry pillars, or a pancake-type progressive collapse of wooden floors (which had significant in-plane flexibility and no connections to masonry walls). Damage to rural buildings had a psychological impact on inhabitants, but did not cause significant economic losses.

**Figure 3.** Collapse of rural masonry buildings: (a) Corner mechanism; (b) Out-of-plane mechanism of wall.

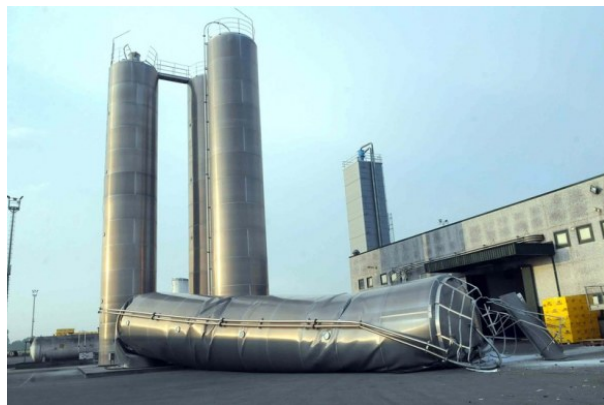
Apart from a few cases where silos and other industrial facilities collapsed (Figure 4), casualties and most of the total economic loss were caused by the catastrophic failure of buildings. The majority of the industrial buildings located in the affected area have structural systems made of precast RC elements (which are widely used in Italy [9]), precast, prestressed concrete (PC) elements, and steel frames. A smaller number of industrial buildings are also made of masonry walls, hybrid masonry-RC systems, and timber frames.

**Figure 4.** Collapse of steel silo due to overturning.

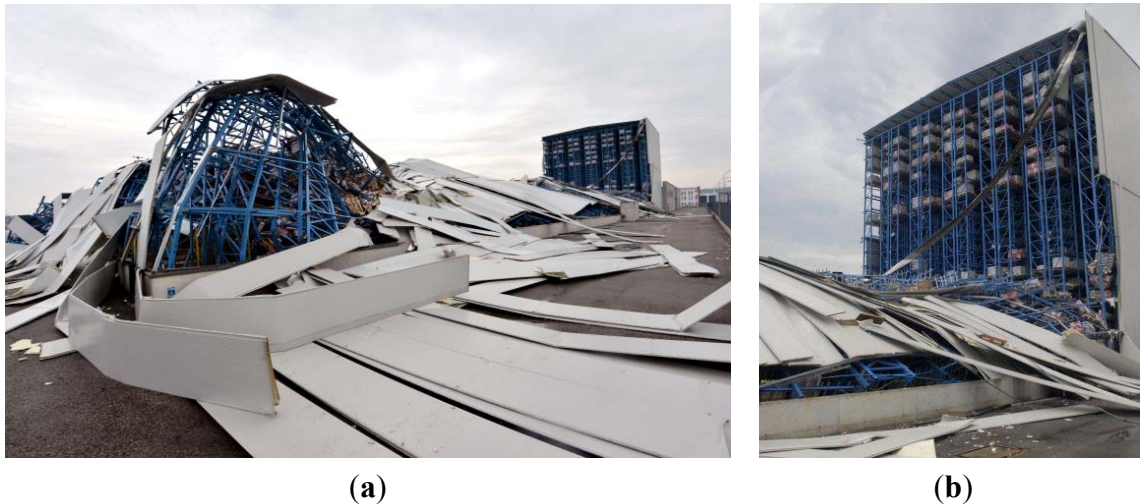
Figure 5a,b shows a pottery warehouse in Sant'Agostino which collapsed during the 20 May earthquake, resulting in two casualties. That facility was used to store boxes of ceramic tiles, and was composed of 12 rows of shelves, each of them consisting of two parallel multi-level parallel steel frames along the longitudinal direction of the building plan [10]. The frames were transversally connected to each other at the roof and foundation levels by means of a truss system; no braces were used in the longitudinal direction. The warehouse was enclosed by sandwich insulation panels. The presence of heavy nonstructural masses especially at upper levels induced a severe dynamic demand on the steel frames and hence the collapse of approximately 2/3 of the building. Figure 6a,b shows a partially collapsed building in Medolla with a storage steel structure which experienced large lateral

**Figure 5.** Pottery warehouse: (a) Totally collapsed section; (b) Undamaged section.

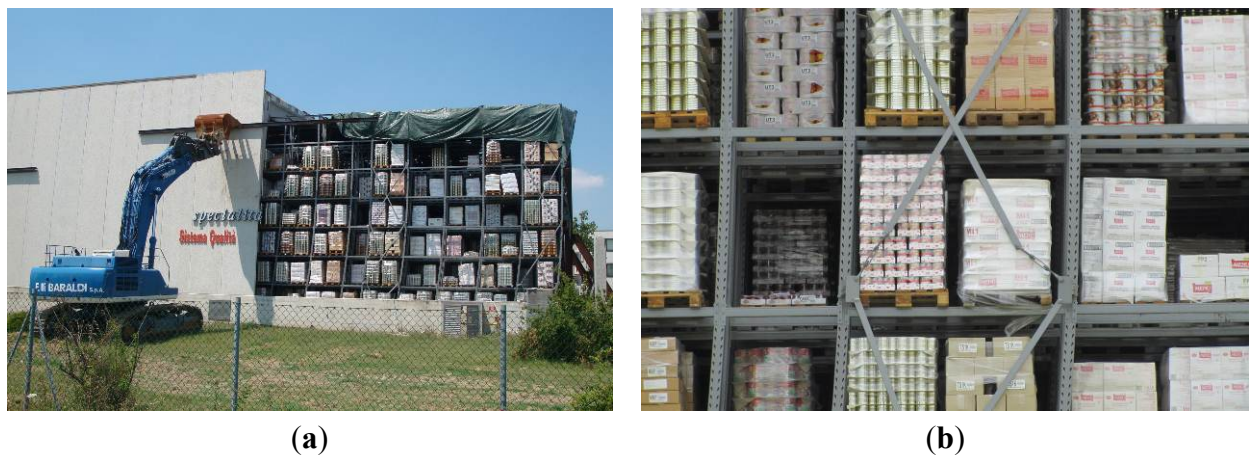
deformations due to the massive stored contents. The lateral deformation of the structure was not prevented by the small size of steel elements, nor by X-braces (Figure 6b).

**Figure 6.** Storage building with internal braced steel scaffolding system: (a) Global view; (b) Failed connection of steel brace.

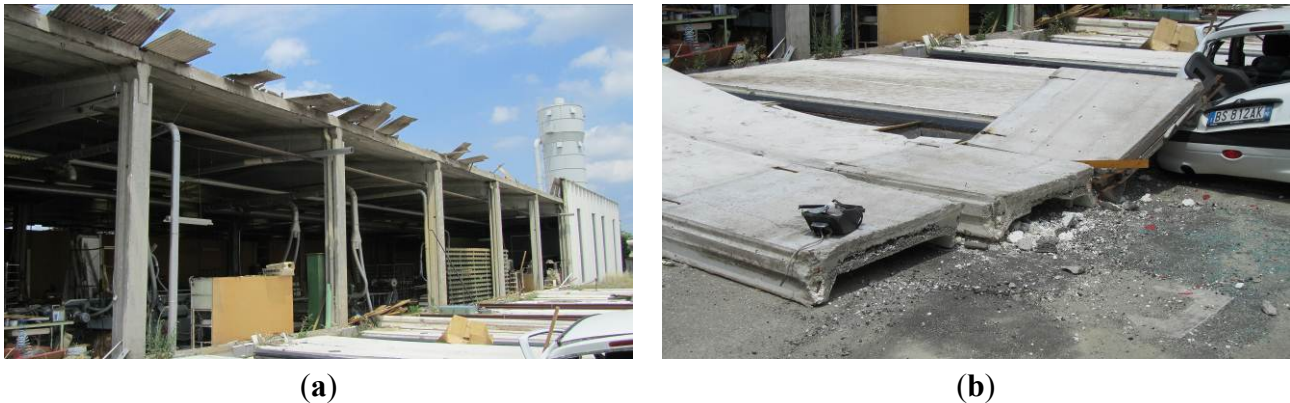
Overturning of façade panels was a typical mechanism observed during field inspections. Figure 7a shows that this type of damage was suffered by an industrial building located in Cavezzo. Although the weight of such panels was significant (Figure 7b), they were poorly connected to the edge roof beam through a few steel bars (Figure 8a) and to the base of the structure through U-shaped seats of RC ground beams (Figure 8b).

**Figure 7.** External view of precast reinforced concrete (RC) building with tilted façade panels: (a) Damaged façade; (b) Detail of heavy façade panels.

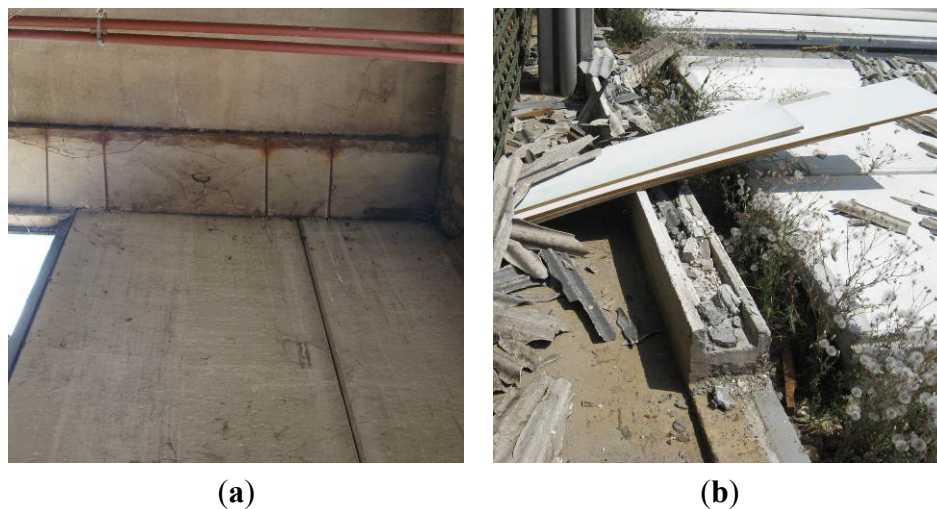
**Figure 8.** Connections between façade panels and RC structure: (a) Panel-to-edge beam connections; (b) Panel-to-ground beam connections.

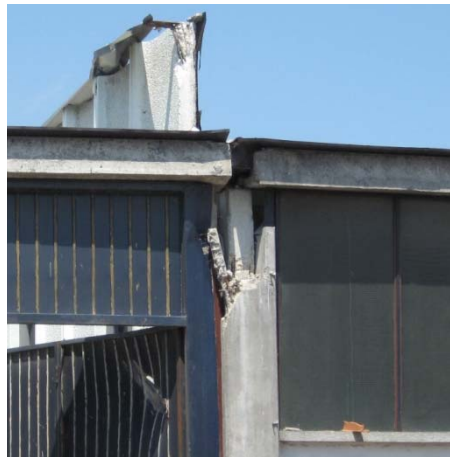
Figure 9 illustrates a damaged U-shaped seat on the top of a column that was built up to provide dry friction supports to the roof beam. The lack of bracing systems contributed to the uncoupled response of roof and vertical structural elements, which included the torsional rotation of roof beams and the resulting flexural damage to flanges of their U-shaped seats. Many similar cases of collapse can be found in post-earthquake field observation reports [5,10,11].

**Figure 9.** U-shaped seat damaged by twisted roof beam.

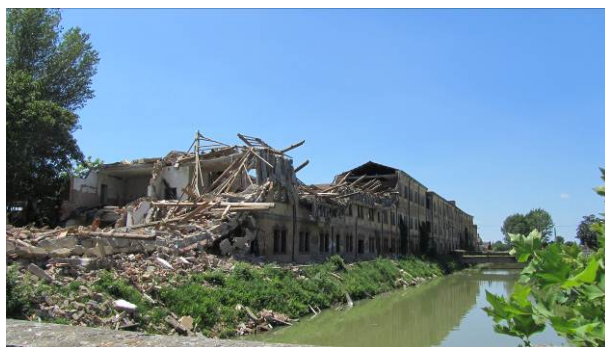
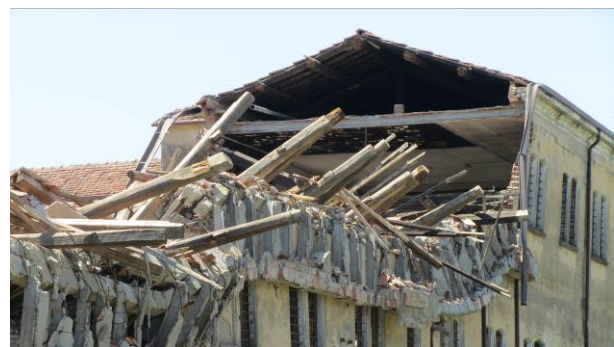
Some industrial masonry buildings were also destroyed in 2012 Emilia Romagna earthquakes. Figure 10a,b shows a three-story industrial building located close to Massa Finalese that partially collapsed during the 20 May 2012 earthquake. The structure was composed of load-bearing clay brick masonry walls with openings, one-way RC joist slabs with tiles, and a pitched wooden roof.

**Figure 10.** Industrial masonry building partially collapsed: (a) Global view; (b) Detail of collapsed story.

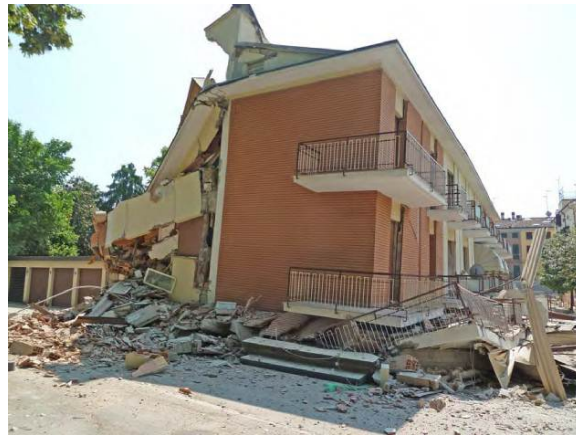
Residential RC buildings in the affected region are typically masonry infilled RC frames with the infrequent inclusion of RC shear walls at the location of stairwells and elevators. A few buildings experienced global collapse as result of soft storey mechanisms at the ground floor. Figure 11 shows a RC building with pilotis in Cavezzo, where the whole ground floor disappeared and also a part of upper stories collapsed. Similar collapse modes were observed at L'Aquila, Italy [2].

**Figure 11.** RC building with pilotis at the ground floor.

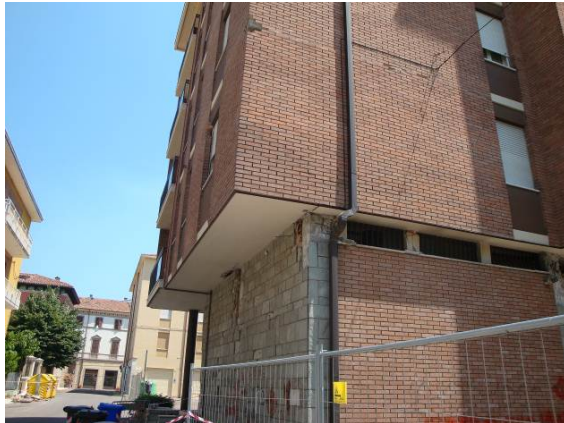
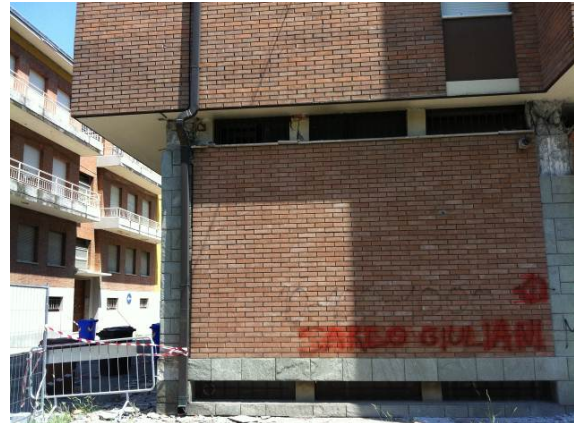
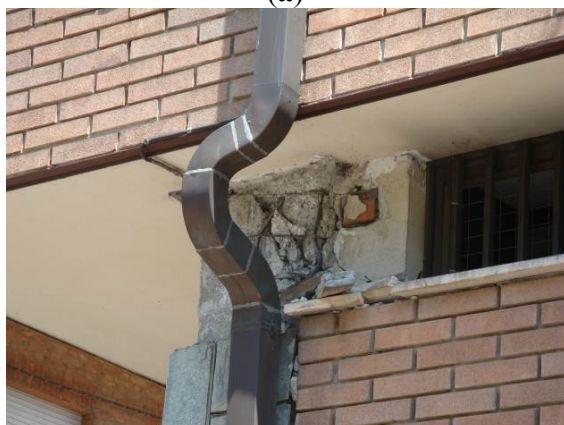
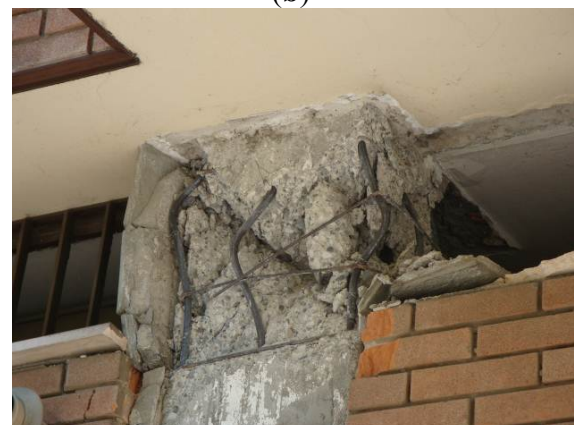
The 2012 Emilia Romagna earthquakes confirmed the influence of masonry infills on the seismic response of RC framed buildings. Partially infilled frames suffered shear collapse of columns as shown in Figure 12a–d. Earthquake damage due to infill wall-RC frame interaction can be seen in Figure 13a,b, which demonstrate the clear formation of a strut resisting mechanism inside the masonry infill and the resulting cracking of an adjacent RC column.

**Figure 12.** (a) Corner view of damaged building; (b) Partially infilled RC frame at the ground floor; (c) Shear failure of corner column; (d) Shear failure of peripheral column.

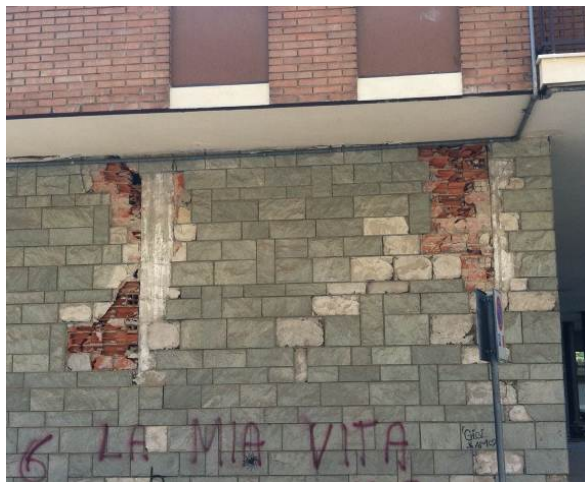
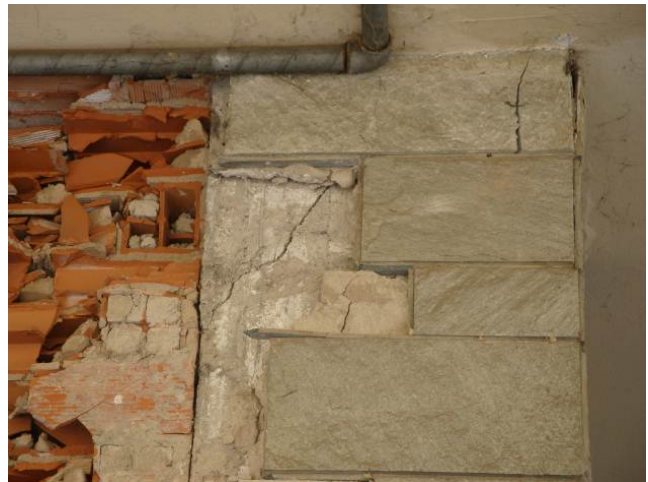
**Figure 13.** (a) Damage to infill masonry walls; (b) Diagonal crack propagation from infill wall to RC column.

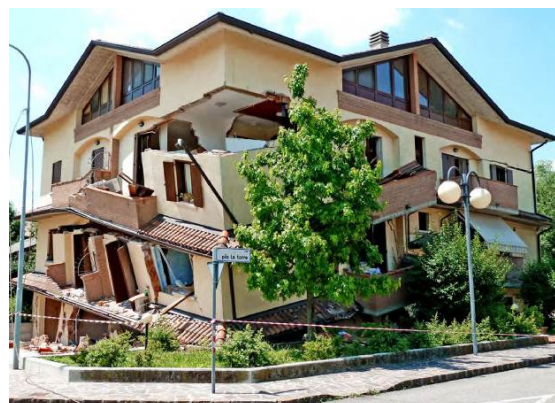
Most modern URM dwellings suffered slight damage ( $I_o = 1-2$  MCS). Higher damage levels ( $I_o = 3-4$  MCS) were detected in some buildings, which exhibited large cracks, whereas a lower number of URM buildings reached partial or total collapse. Soil liquefaction induced extensive crack patterns within URM dwellings, as a result of settlement-induced differential displacements, uplift, or lateral spreading. This type of damage was mainly observed in San Carlo and Mirabello. Figure 14 shows the impressive collapse of a newly constructed URM building located in Rovereto (fraction of Novi di Modena), which had a portico at the ground floor. That collapse phenomenon clearly demonstrated that a masonry structure does not behave monolithically under a differential settlement caused by a liquefied ground movement, particularly if the foundation system does not have sufficient flexural stiffness. Figure 15 illustrates a residential masonry building in Rovereto that probably collapsed because of its structural deficiencies. This hypothesis is motivated by the fact that similar adjacent buildings did not suffer heavy damage.

**Figure 14.** Liquefaction settlement-induced collapse of masonry building.

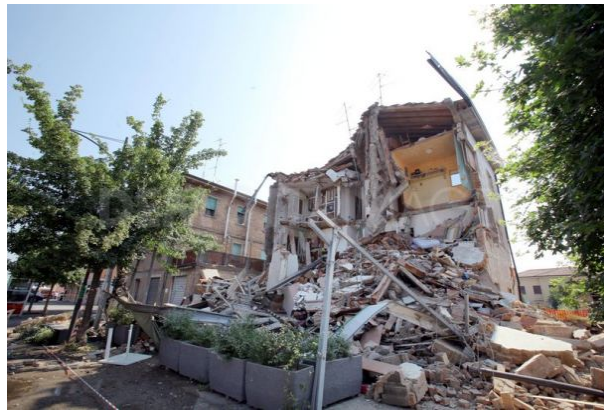
**Figure 15.** Global collapse of masonry building.

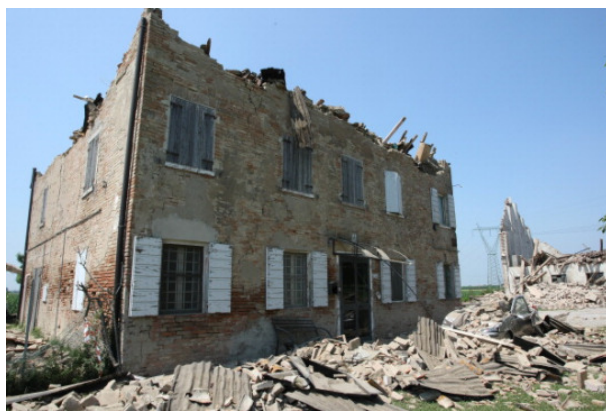
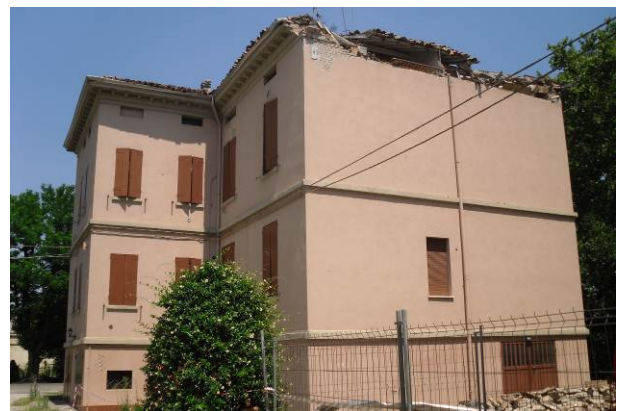
An earthquake-resistant URM building should have masonry interlocking between orthogonal walls, an effective connection between floors and walls through RC tie beams or steel ties, and floor systems with sufficient in-plane stiffness able to distribute horizontal seismic actions among walls. Both old and modern URM buildings located in the affected region did not have one or more of these earthquake-resistant measures, so they suffered local collapses (Figure 16a,b).

**Figure 16.** Out-of-plane collapse of peripheral load-bearing masonry walls at the level of thrusting pitched roofs: (a) Building in Cavezzo; (b) Building in Mirandola.

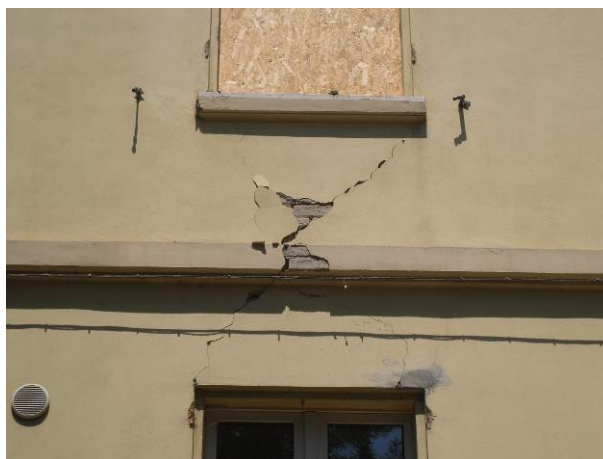
If local collapse mechanisms are prevented, a global “box-type” seismic response takes place. The distribution of horizontal seismic actions among walls induces the in-plane lateral loading of individual masonry walls, which typically suffer a concentration of damage in macroelements between openings [12]. Pier and spandrel panels, namely, the vertical and horizontal macroelements, are usually defined in the macroelement mesh of masonry walls with openings. When such macroelements are subjected to in-plane lateral loading, shear or flexural cracking can occur. Figure 17 shows diagonal shear cracks in spandrel panels observed in modern masonry buildings located in Mirandola. Significantly different damage patterns were detected in the case of masonry walls with irregular layout of openings (Figure 18a,b), which often develop a lower seismic capacity compared to their regular counterparts [13].

**Figure 17.** Diagonal shear cracks in spandrel panel.

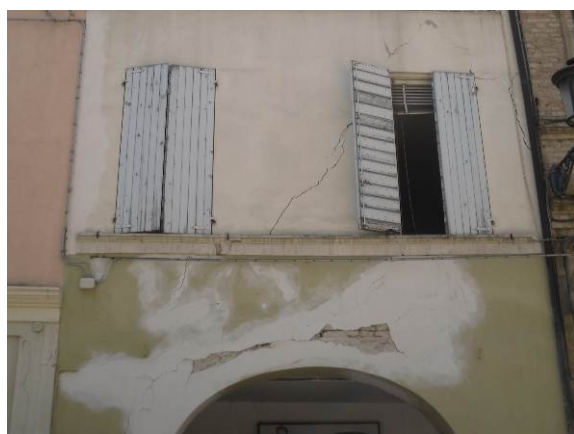
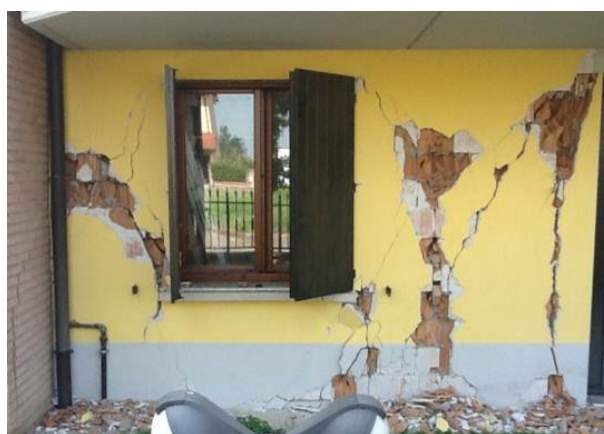
**Figure 18.** Damage to irregular masonry walls with openings: (a) wall irregularity due to different number of openings between two stories; (b) wall irregularity due to different opening heights at the same story.

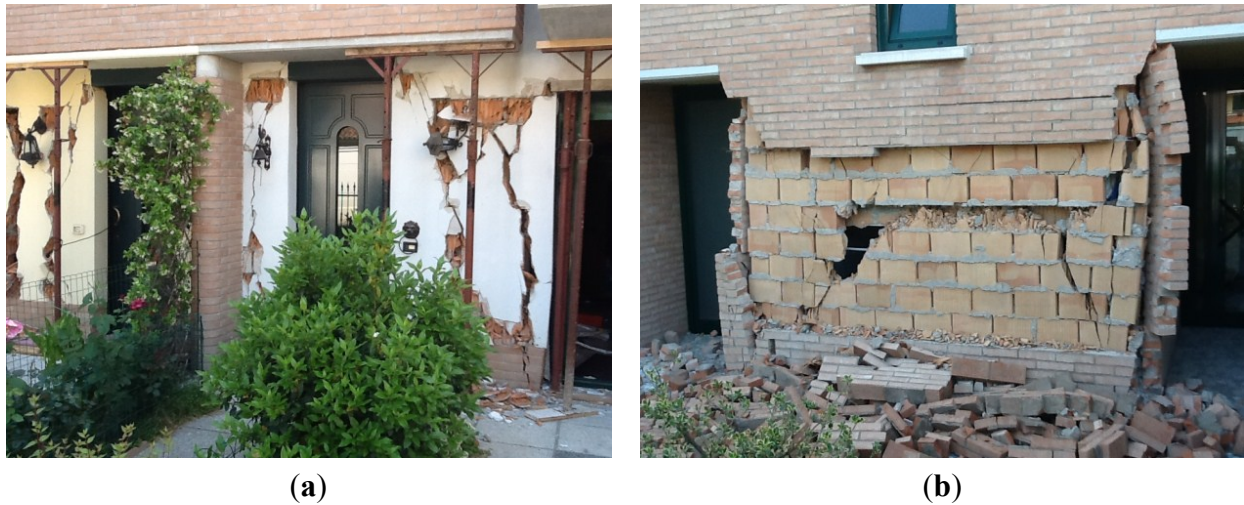
Several two- and three-story URM dwellings located in Rovereto were seriously damaged by the May 2012, earthquake and partially collapsed. These buildings were constructed in the last decade and their structure was composed of load-bearing hollow brick masonry walls. Figure 19a,b show large cracks in piers and the collapse of external brick masonry leaf, respectively. Figure 20 illustrates a strange failure mode of building corners. URM dwellings located in the same area suffered just slight damage, indicating that adjacent houses with heavy damage could have been built with poor quality materials and/or incorrect construction procedures.

**Figure 19.** Heavy damage to hollow brick masonry piers: (a) Large sub-vertical cracks; (b) Ejection of external leaf and diagonal shear cracks in hollow brick masonry core.

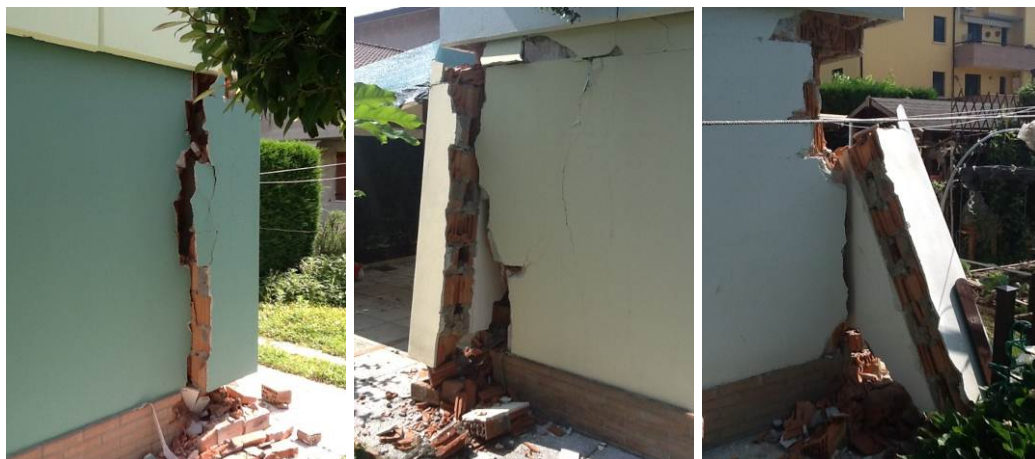
**Figure 20.** Corner failure of hollow brick masonry building.

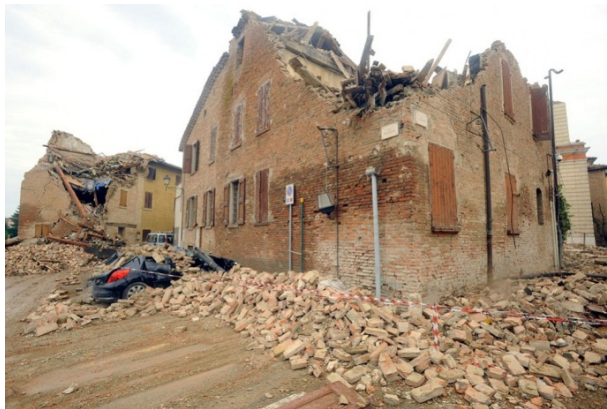
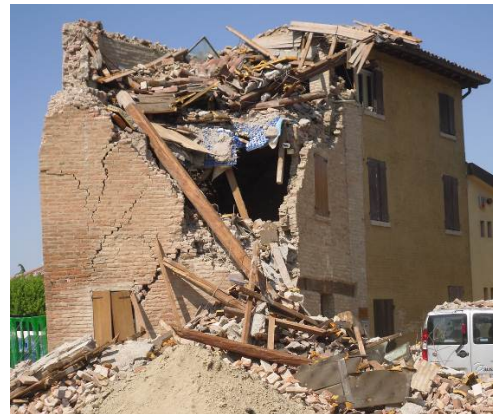
Many historical buildings, including churches, bell and clock towers, castles, and palaces, were partially or completely destroyed, as also reported after other past earthquakes, such as the 2009 L'Aquila earthquake [2]. The 2012 Emilia Romagna earthquakes confirmed the high fragility level of (a) bell and clock towers which are prone to suffer torsional cracks; and (b) tympanums of churches and masonry buildings without RC tie beams or steel ties which are prone to suffer out-of-plane failure mechanisms (Figure 21a,b); such as vaults and domes which often suffer horizontal shear cracks under large relative displacements of load-bearing walls.

**Figure 21.** Out-of-plane corner mechanisms of brick masonry building units located in the historical center of San Felice sul Panaro: **(a)** Collapse of one story; **(b)** Collapse of two stories.

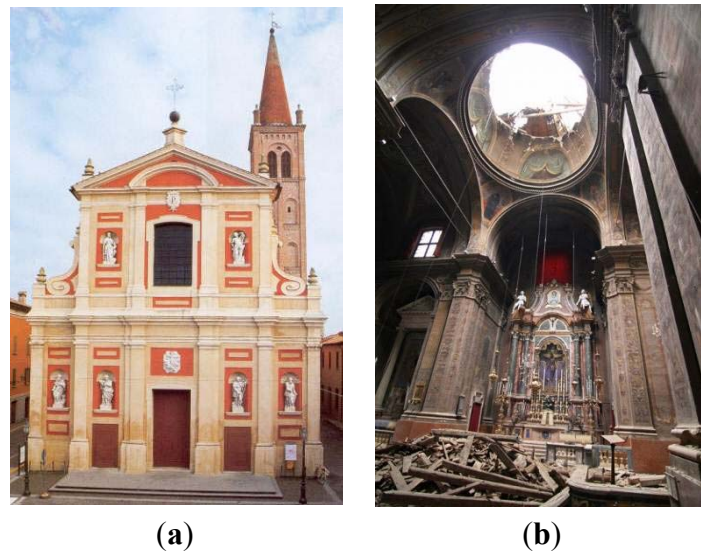
The Colleggiata di Santa Maria Maggiore, a baroque church with high cultural value located in Pieve di Cento (Figure 22a), was significantly damaged by the 29 May 2012 earthquake. That church is the oldest one in the area and its apse was built in the second half of the 14th century whereas almost the rest of the building was reconstructed between 1702 and 1710. The church has a single nave with lateral altars. The bell tower was built up in 1487 with Romanesque-Renaissance style and is 48 m high; actually, the tower was constructed on the former structure, which partially collapsed, and the bells were produced in 1809 in Reggio Emilia. The 29 May earthquake caused the partial collapse of the dome (Figure 22b), a crack at the top of the bell tower, cracks on the main façade and other walls, and heavy damage to artwork.

**Figure 22.** Church Colleggiata di Santa Maria Maggiore: (a) Main façade before the earthquake; (b) Partially collapsed dome.

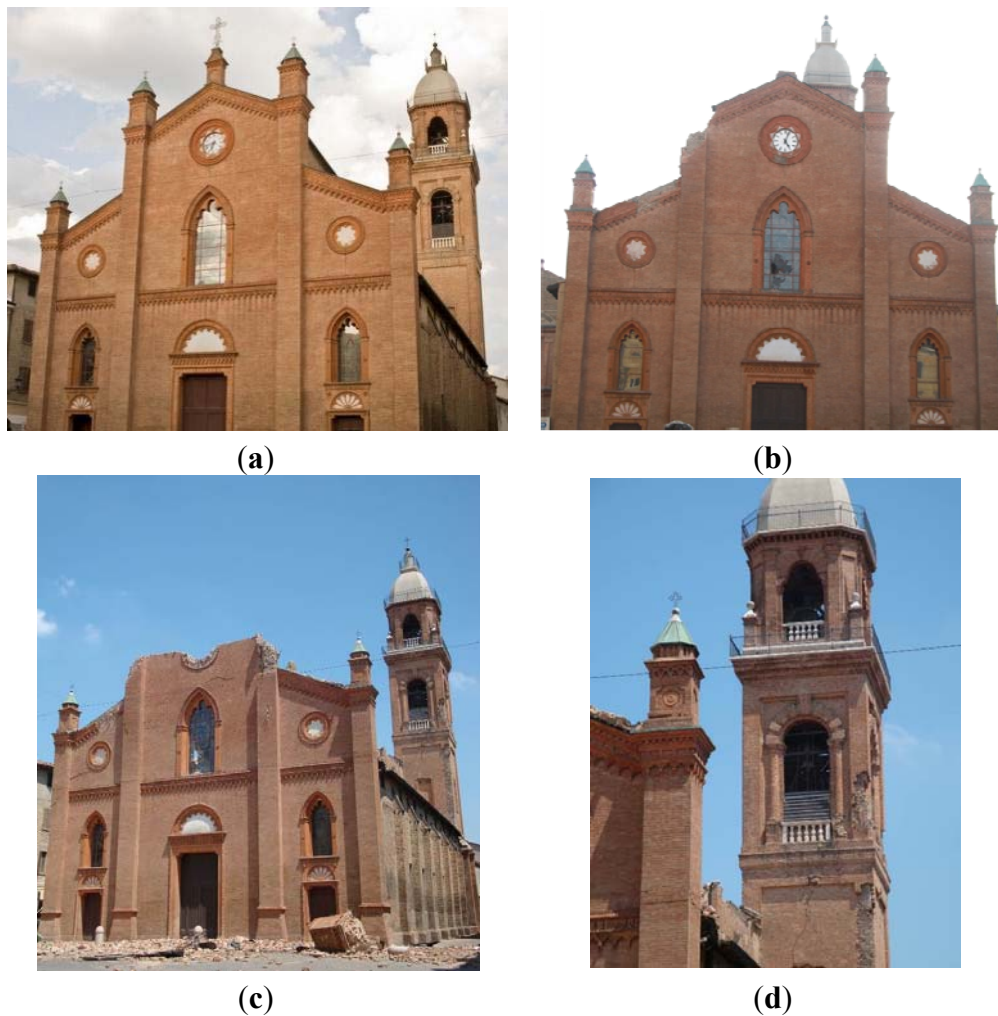
The Cathedral of Santa Maria Maggiore suffered cumulative damage during the 20 and 29 May 2012 earthquakes. The church has a three-nave basilica-type cross plan with a bell tower to the right of the apse (Figure 23a). Decanini *et al.* [5] carried out field inspections after the 20 May earthquake, identifying some iron ties that connect the main façade to the orthogonal walls (*i.e.*, the longitudinal walls of the naves). Iron ties were also identified in the bell tower below the lower gable. The main façade was built in the 19th century, whereas the bell tower was constructed for the first time in 1449 and then was reconstructed in the 17th century. The 20 May earthquake caused some cracks in the bell tower and the loss of the upper left spire of the main façade (Figure 23b) in which out-of-plane collapse mechanism was effectively prevented by iron ties and connection to orthogonal walls. The 29 May earthquake caused damage propagation. The yielding of iron ties of the main façade caused the out-of-plane collapse of the tympanum (Figure 23c); furthermore, the upper right spire collapsed and the bell tower suffered heavier damage (Figure 23d).

**Figure 23.** Cathedral of Santa Maria Maggiore in Mirandola: (a) Overall view before the 2012 Emilia Romagna earthquakes; (b) Main façade after the 20 May 2012 earthquake; (c) Overall view after the 29 May 2012 earthquake; (d) Large diagonal cracks in the bell tower.
