The 2011 Earthquake in Simav, Turkey and Seismic Damage to Reinforced Concrete Buildings

Abstract: Reinforced concrete buildings suffered significant damage in the region affected by the 29 May 2011 earthquake in Simav (Kütahya), Turkey. Typical building damage is classified and potential causes of damage are investigated. Reinforced concrete moment resisting frames with hollow brick infill walls are the most common structural system in and around the Simav city center while masonry construction is common in rural areas. Although the Simav earthquake, with a magnitude of 5.7 to 5.9, can be classified as a moderate earthquake, many buildings experienced damage varying from frequent diagonal cracking and brittle failure of infill walls to collapse or severe damage to frames due to short columns, soft stories or other reasons including insufficient or poor detailing of reinforcement. This study investigates and presents the seismicity of the region, characteristics of the measured ground motions, seismic load demands including response spectra, and damage mechanisms, potential causes and classification of observed damage in reinforced concrete buildings.

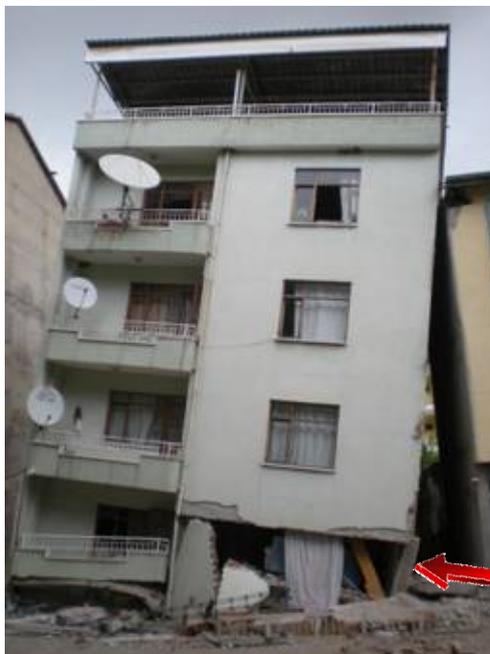
A weak or soft story in a building has relatively low lateral strength or stiffness compared to those of the stories above or below that story. Weak and soft stories are typically observed in the first story of reinforced concrete buildings in Turkey. In multi-story buildings the first story is used as garage, office space, or usually for commercial purposes. As a result, a typical first story has: (1) taller columns with resulting lower lateral stiffness; (2) much less infill walls between the columns leading to lower lateral strength and stiffness compared to upper stories; and (3) rectangular columns with their weak axis mostly perpendicular to the street, *i.e.*, weaker columns, thus weaker story in one direction [10]. With less stiff, taller or weaker columns and less infill walls, the first story experiences larger lateral drifts. Soft and weak stories have been one of the most common reasons for damage or collapse of multi-story reinforced concrete buildings in Turkey [10–12] and in other parts of the

world [13,14]. In the building shown in Figure 8, first story columns were severely damaged which led to collapse while the upper stories suffered virtually no damage. Even the windows are not broken in the upper stories because the deformation demand in the upper stories was limited.

Figure 8. Building collapse due to first story failure during the Simav earthquake.

1. Soft and weak first stories were observed in reinforced concrete buildings near the city center because the first story of most of these buildings are taller than upper stories and are used as commercial space with less infill walls.

Existing buildings with a soft or weak story can be strengthened by increasing the stiffness and strength of the soft or weak story. The TEC [9] recommends addition of structural walls as a practical retrofit method. This strengthening is currently mandatory for existing buildings in seismic zones 1 and 2, which are the two seismic zones with the highest earthquake risk with corresponding ground acceleration $a_g \geq 0.4g$ and $0.3g$, respectively. These buildings typically consist of reinforced concrete flat slab, bare or infill joist system, and waffle slab system with columns and beams not satisfying the requirements for high ductility level.

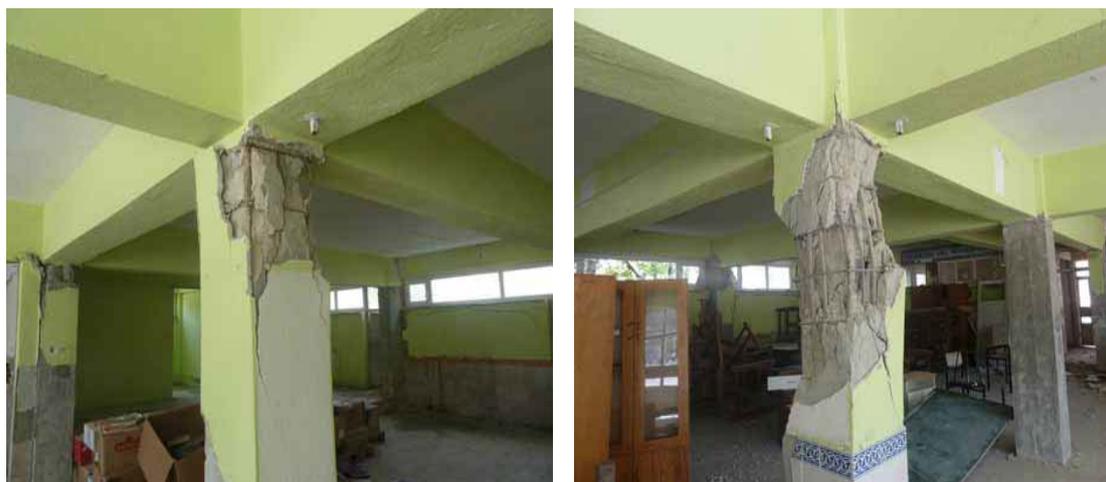
Reinforced concrete frames need to be designed for both strength and ductility in order to prevent severe damage that can be caused during a strong earthquake. Strength is the maximum shear, axial or moment capacity of a structural member or the structural system to resist the earthquake loading, and ductility is related to maximum deformation capacity. In order to avoid collapse during an earthquake, columns need to be designed stronger than the beams in a reinforced concrete frame. This phenomenon is called strong column and weak beam concept. The beams are supposed to be ductile and controlled damage or plastic hinges are supposed to occur at end of beams rather than in columns. In order to dissipate sufficient energy within the plastic hinges, plastic hinge regions should have special reinforcement detailing to improve the energy absorption capacity and ductility. However, reinforced concrete frames with weaker columns suffer brittle shear and axial failure while the stronger beams remains elastic. This undesirable behavior is also seen in the 2011 Simav earthquake. Figure 9 shows column failures in a building with strong beams and weak columns.

Figure 9. The failure of strong beam-weak column.

Figures 9 and 10 show the large transverse reinforcement spacing in the columns. Widely spaced and insufficient transverse steel leads to: (1) lower column shear strength; (2) less effective confinement of the core concrete and lower core concrete strength; and (3) buckling of the longitudinal bars under increased axial and lateral loads. The effects of inadequate transverse reinforcement are further discussed below.

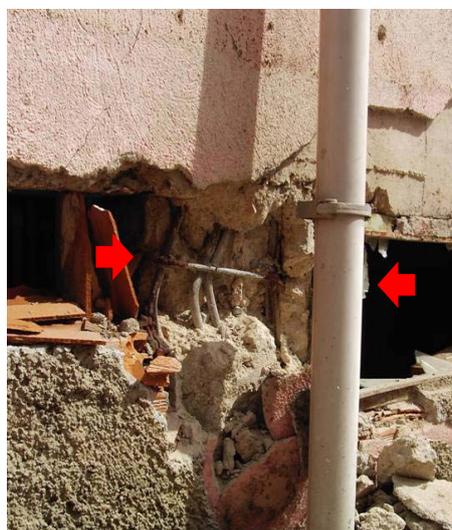
Many reinforced concrete buildings were seriously damaged in past earthquakes due to presence of short columns [10,15]. Short columns can be classified into two groups. The first group consists of columns that are designed or constructed shorter than other columns in that story. The second group includes columns that are shortened during construction by adding partial walls or panels on both or either side of the columns although their specified height is the same as other columns in that story in the original design. Damage in these short columns is often in the form of X-shaped cracking due to brittle shear failure. Examples of short column failures from the 2011 Simav earthquake are shown in Figure 10.

Figure 10. Short column and non-ductile column failure.

2. As in previous earthquakes in Turkey, brittle shear failure of short columns was observed in this earthquake. Partial infill walls built on both or either side of columns created short columns in many buildings.

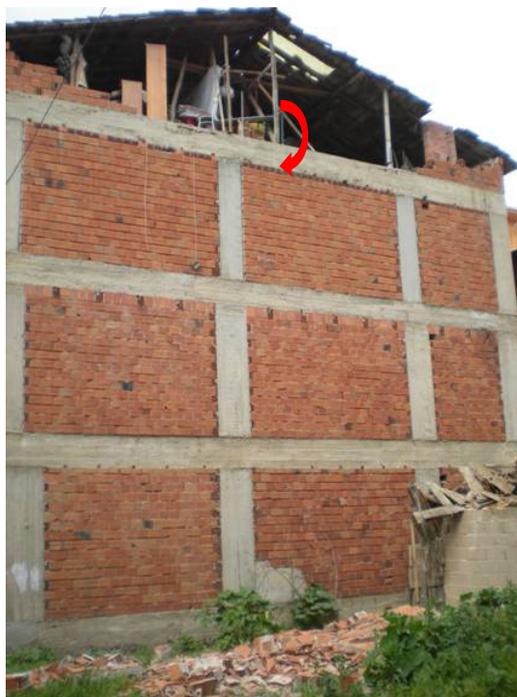
Unconfined gable wall damage has been common in recent earthquakes in Turkey. Although the structural integrity of the building is not compromised due to the gable wall damage, such damage results in falling hazard that leads to financial loss, injuries and even fatalities [11]. An example of unconfined gable wall damaged in the Simav earthquake is shown in Figure 11. In order to limit the gable wall damage, the Turkish earthquake regulations [9] require vertical and inclined concrete beams within the wall if the roof gable wall is taller than 2.0 m (Figure 12).

Figure 11. Unconfined gable wall damage.

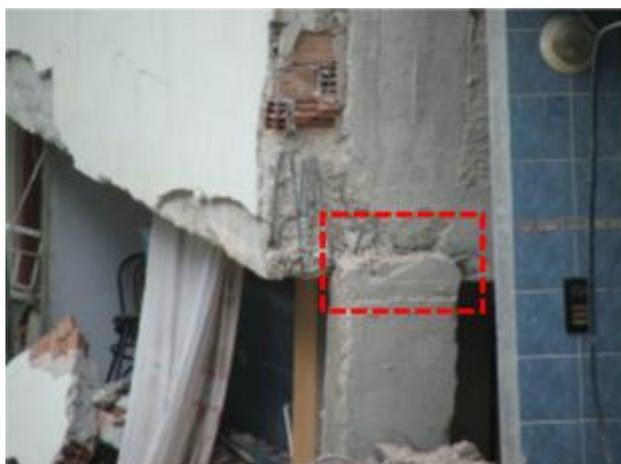
Beam-column joints are designed to transfer moments and resist lateral loads within the beam-column moment frame system. Transverse reinforcement needs to be provided within the joint region to resist shear forces and confine concrete [17]. Some buildings were damaged in Simav because of insufficient lateral reinforcement in the beam-column joints (Figure 13). No confinement or lateral reinforcement exist in most joints, making them unable to achieve the required ductility. Beam-column joints of high ductility frame systems are classified as confined or unconfined joints in the TEC [9]. A beam-column joint is defined as a confined joint if beams frame into all four sides of a column and the width of each beam is not less than three quarters of the adjoining column width. In practice, it is rather difficult to satisfy this requirement. All joints not satisfying the above given conditions are defined as unconfined joints.

TEC [9] requires 135-degree hooks at the end of seismic transverse reinforcement, because 90-degree hooks easily open and lose their effectiveness. As the labor or installation is difficult, transverse steel with 135-degree hooks has not been used until recently. However, with more government oversight and better supervision at the construction site, TEC [9] requirements appeared to be carefully applied in the field within the last five years.

Figure 13. Inadequate transverse reinforcement in beam-column joints.

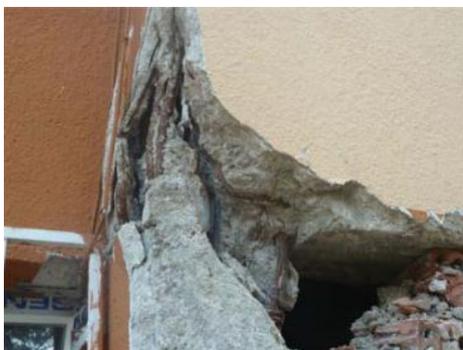
As discussed in the previous section, reinforcement detailing is critical in seismic design of reinforced concrete structures because the ultimate strength and displacement ductility highly depend on the amount and detailing of the reinforcement. The authors observed severe damage and collapse of structures mainly due to poor reinforcement detailing (Figure 14). Most common problems included insufficient or lack of longitudinal bars, and insufficient development length, lap splices, or anchorage of rebar. These problems were exacerbated by corrosion of rebar and concrete damage and spalling. Although the corrosion was typically not severe in longitudinal bars in buildings damaged during the earthquake, some corroded rebar were spotted typically at the column-foundation interface.

Figure 14. Poor reinforcement detailing at a column end [6].

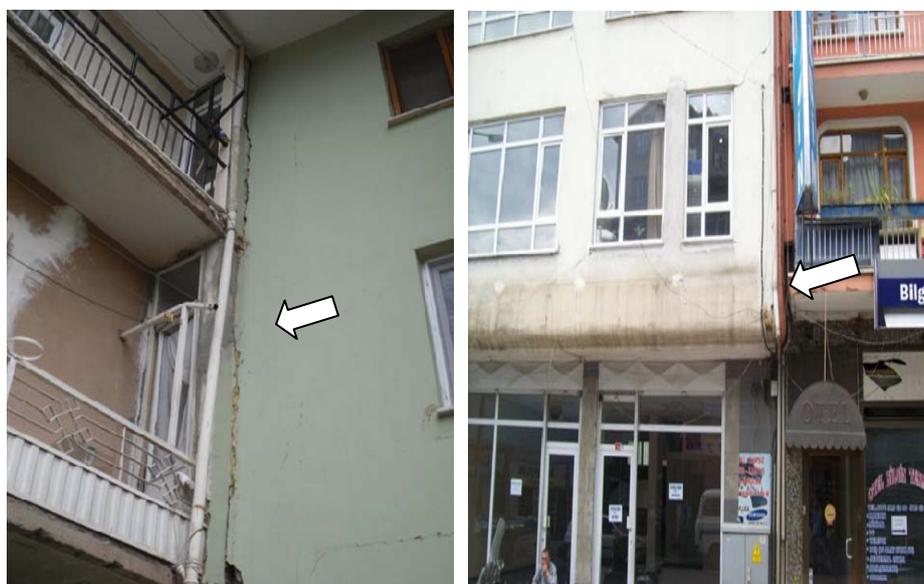
periods of two adjacent structures cannot always be the same because periods of the buildings depend on variation of mass and structural system stiffness of the building. Dynamic properties of structures, properties of ground motion and gaps between closely spaced structures have influence on the location and magnitude of pounding. In addition, soil type can affect the structural response in terms of both fixity of the building foundations and periods of the structures. The simplest and most practical way to prevent this impact and reduce damage is to provide enough separation. Corner buildings are expected to experience more damage than interior buildings because of pounding, since corner buildings are free to move in many directions. If the required sufficient space or gap cannot be provided, an alternative solution is to decrease the lateral motion and drift of buildings. Pounding of closely spaced buildings is frequently observed during earthquakes in Turkey because it is very common to have very small separation or no gap between adjacent buildings. Two pounding examples resulting from inadequate gap between adjacent buildings are shown in Figure 15.

Figure 15. Pounding between closely spaced buildings.

3. As there was not enough space between many buildings, flexible buildings hit adjacent buildings and caused damage. It was also observed that corner buildings were damaged more severely as they can move freely in various directions during the earthquake.

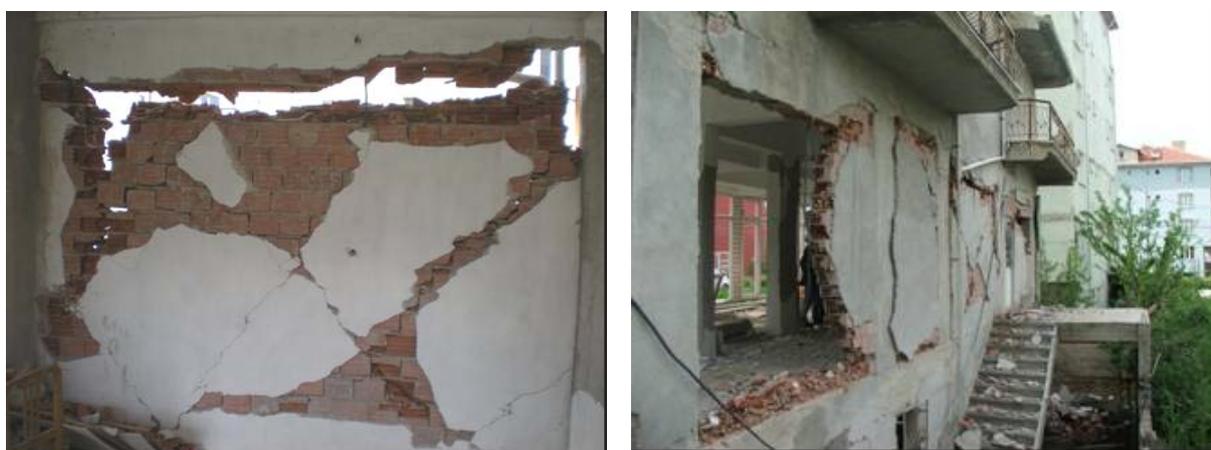
Unreinforced hollow clay bricks were used in infill walls of almost all reinforced concrete buildings in the region affected by the 2011 Simav earthquake. Unreinforced infill walls have relatively low lateral strength and usually brittle once their strength limit is reached. Diagonal cracks, a sign of shear failure, in infill walls were commonly observed in reinforced concrete buildings. Depending on the magnitude of the lateral load applied on the building, the level of observed wall damage varied from light diagonal cracks in the walls to separation from the structural frame or out-of-place buckling (Figure 16).

Figure 16. Infill wall damage in reinforced concrete buildings. Damage Caused by Multiple Earthquakes.

4. Unreinforced infill walls increased the lateral stiffness of the buildings and were severely damaged in many buildings. Damaged gable roof walls and infills walls created falling hazard and caused financial loss and injuries.

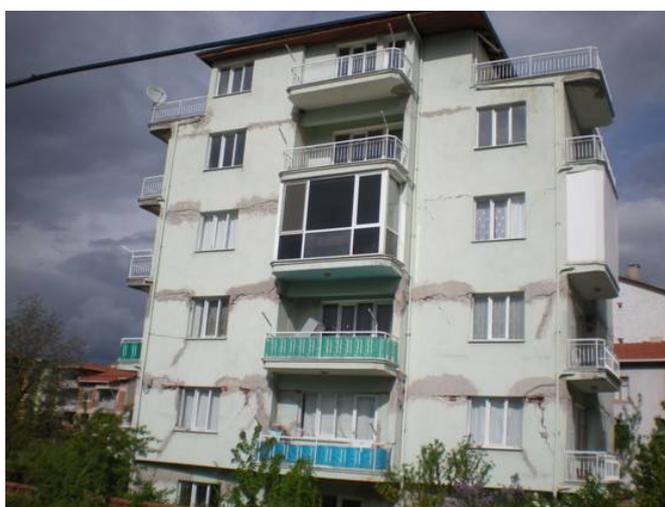
Simav was also hit by a magnitude 5 earthquake in 2009, causing damage in some reinforced concrete buildings. Most of these damaged buildings apparently were not repaired or strengthened, instead they were plastered and painted. The 2011 Simav earthquake caused further damage in those buildings usually at or near the areas damaged during the 2009 earthquake. Figure 17 shows one such building with damaged beams and infill walls plastered after the 2009 earthquake. Large cracks caused by the 2011 earthquake are visible in the second floor, e.g., near the right end of the wall in the second story.

Figure 17. Building damaged during the 2009 and 2011 earthquakes.

6. After a magnitude 5 earthquake struck the same region in 2009, the damaged buildings were not properly evaluated and repaired. After the 19 May 2011 earthquake, the same buildings experienced more severe damage.
