New Method to Identify Field Joint Coating Failures Based on MFL In-Line Inspection Signals

Lianshuang Dai ^{1,2}, Ting Wang ², Caiyan Deng ^{1,*}, Qingshan Feng ² and Dongpo Wang ¹

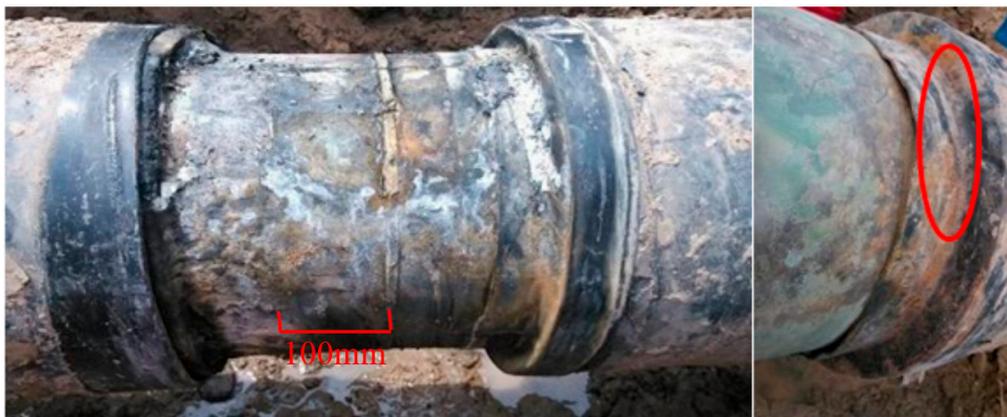
The causes for the corrosion failure of coatings may be ascribed to that the ground water permeated into the insulating layer to produce the enclosed corrosion environment [9]. In recent years, PetroChina Pipeline Company has found numbers of serious external corrosions due to failed FJCs. When FJC is debonded from the pipe without damages, cathodic protection is always shielded, which may cause crevice corrosion and also microbiological corrosion with rapid wall thickness thinning speed [10–14]. Consequently, it is important to identify external corrosion that is caused by failed FJC in advance.

Figure 1. Field joint coating (FJC) failure and cause the pipe body corrosion.

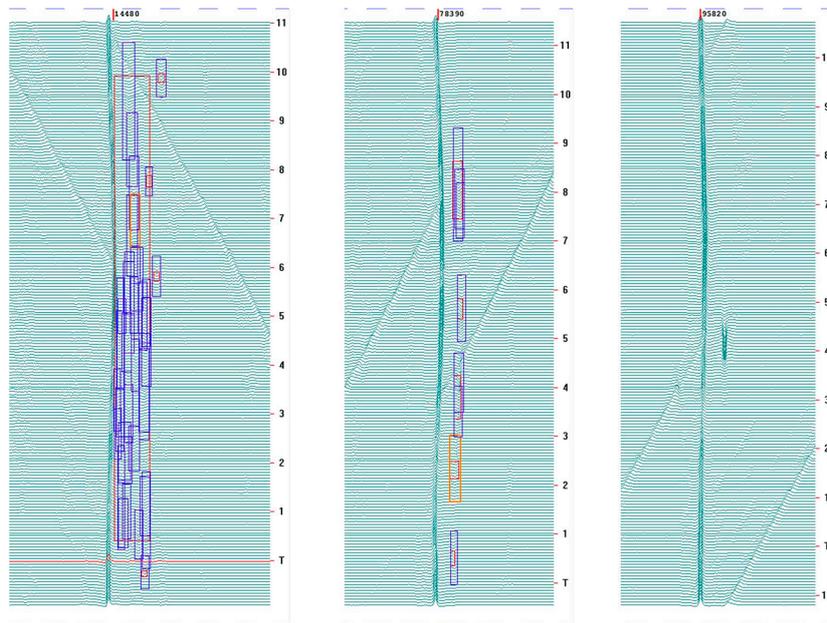
Type 1: Defects cluster together as a band or a ring, or one single corrosion depth is more than 20% wall thickness (WT), as shown in Figure 3. This type is the most likely failed FJCs according to the mechanism when corrosion begins to occur under the disbanding coatings.

Figure 3. Type 1 magnetic flux leakage (MFL) signals.

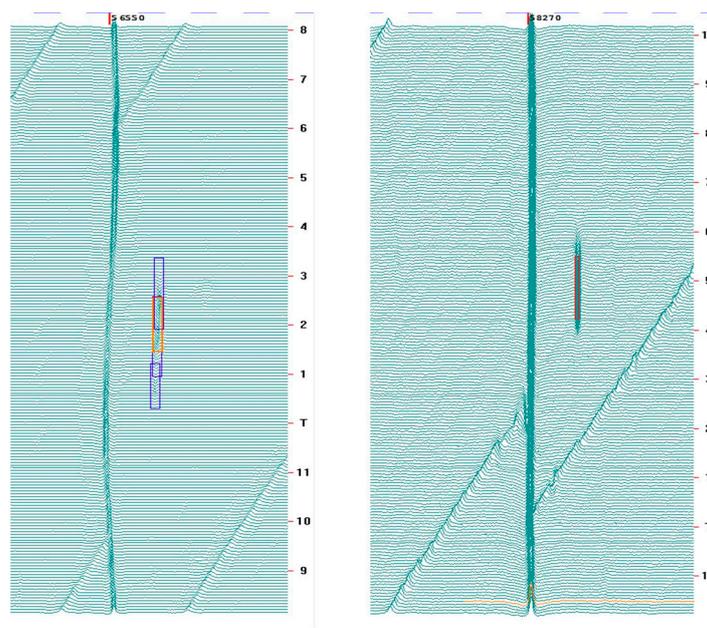
Type 2: Defects cluster or only one defect is reported with relatively long circumferential length, shown in Figure 4. This type is with a certain possibility of FJC failure, which may be the just beginning of pipe corrosion however needs verifications.

Figure 4. Type 2 MFL signals.

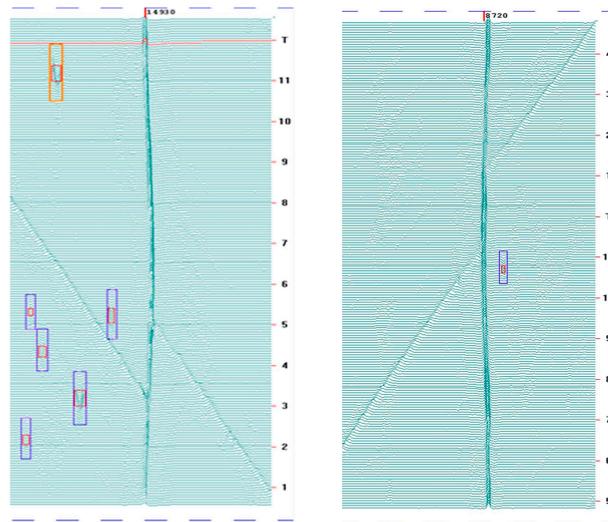
Type 3: Defects are dispersed or single, and all with small sizes, as shown in Figure 5. Though there are metal loss defects that are reported in the field joint zone, these may be manufactured defects that are difficult to be distinguished from corrosion and are possibly not caused by the FJC failures.

Figure 5. Type 3 MFL signals.

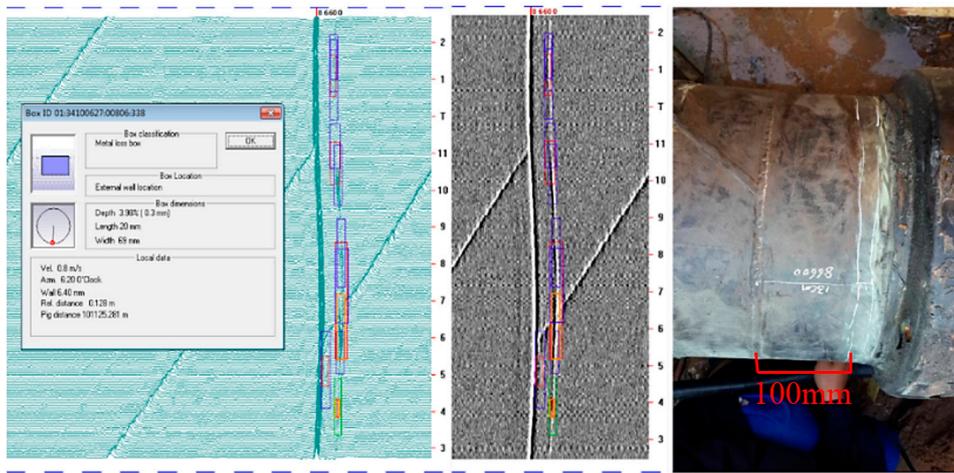
Nearly half of the excavations (42.0%) showed that the FJCs were in good conditions and no defects found, while the metal loss signals shall be caused by the grinding before spraying anticorrosive primer in the field usually with reported depths below 5 wt %, or manufactured defects. Typical signal and excavation picture are shown in Figures 6 and 7. MFL signals are not able to tell and discriminate them from corrosions very well until now. However, there are still some differences in features between

Figure 6. The metal loss signals caused by the grinding.

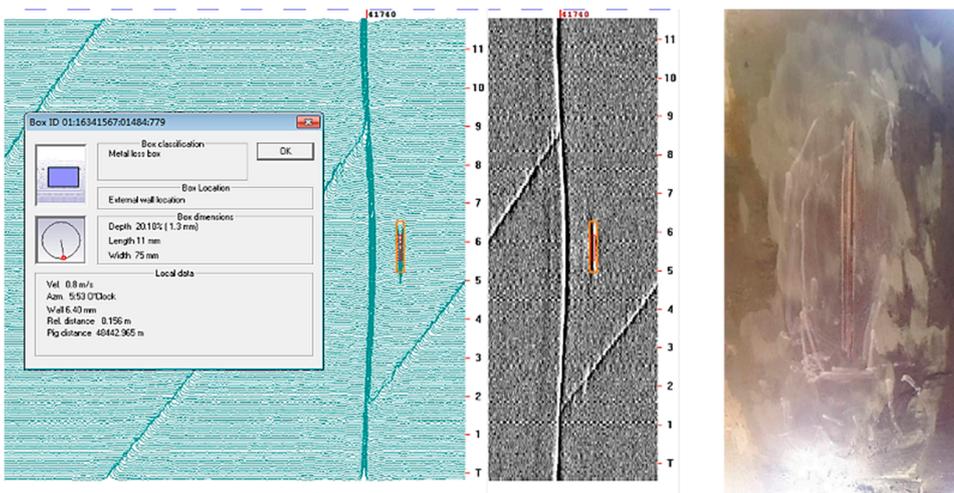
them, such as the signal edges of manufacturing defects are more clear and sharp. There is another way to tell if it is corrosion: for gray-scale signals, there are always riverside pattern lines appearing in the FJC regions when corrosion occurs. See Figure 8.

Figure 7. The metal loss signals caused by the manufacturing.

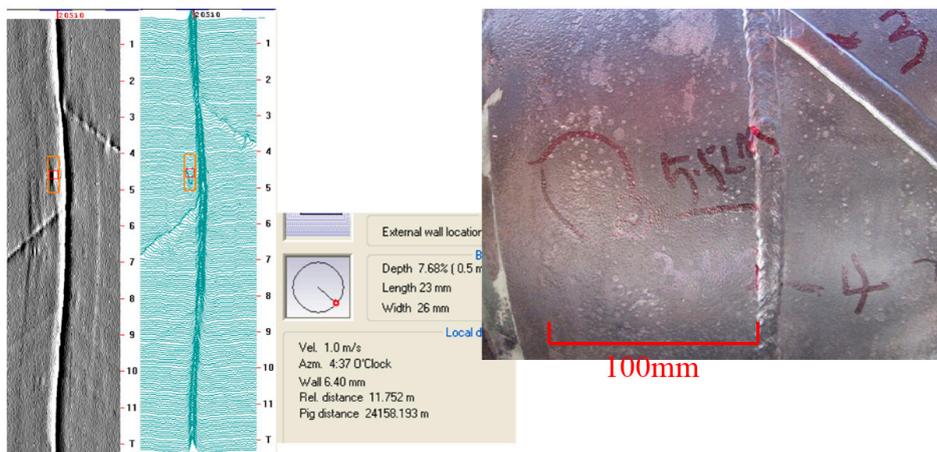
Figure 8. The corrosion signals and picture with riverside pattern.

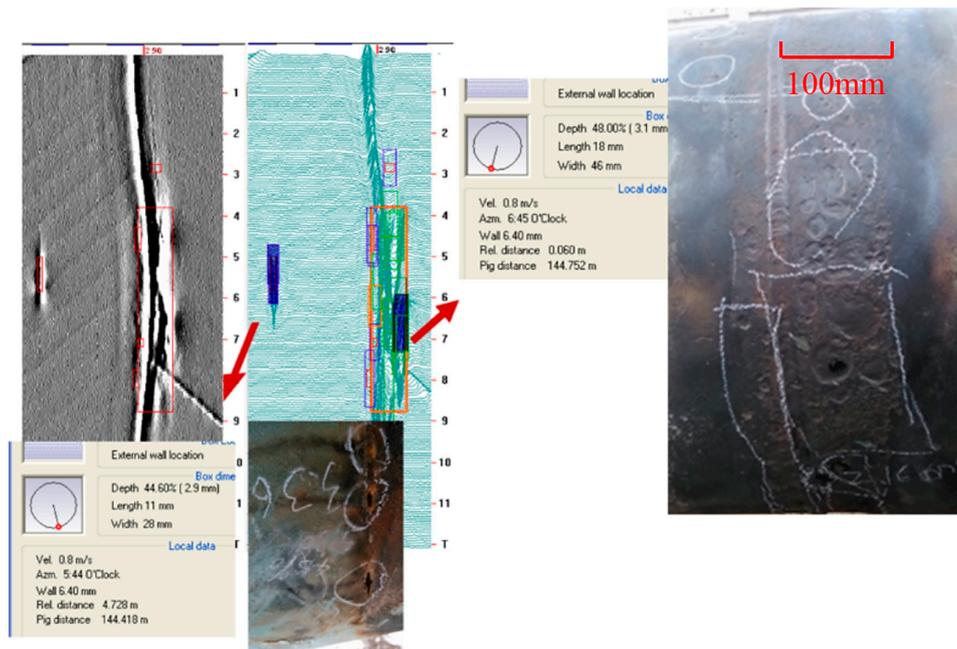
More than half of the excavations (58.0%) showed that the FJCs were failed and the reported defects were corrosions. Though it may not be always true, the patchy like corrosions caused by FJC failures usually distributed in the bottom or near the bottom of the pipe, that is, 4 o'clock to 8 o'clock in orientation. Typical signals and excavation pictures are shown in Figures 9 and 10, usually with reported depths above 10 wt %. As for these two kinds of sections, percentage of corrosions for relatively dry section (44.9%) is lower than that of section (69.9%) with numbers of river crossings.

Figure 9. Typical signals and excavation pictures for corrosion.

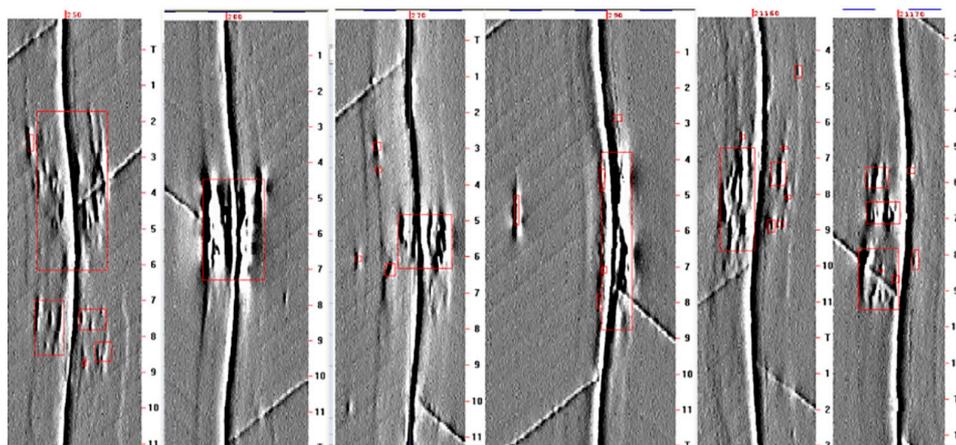
Figure 10. Typical MFL gray-scale signals for FJC failure corrosion.

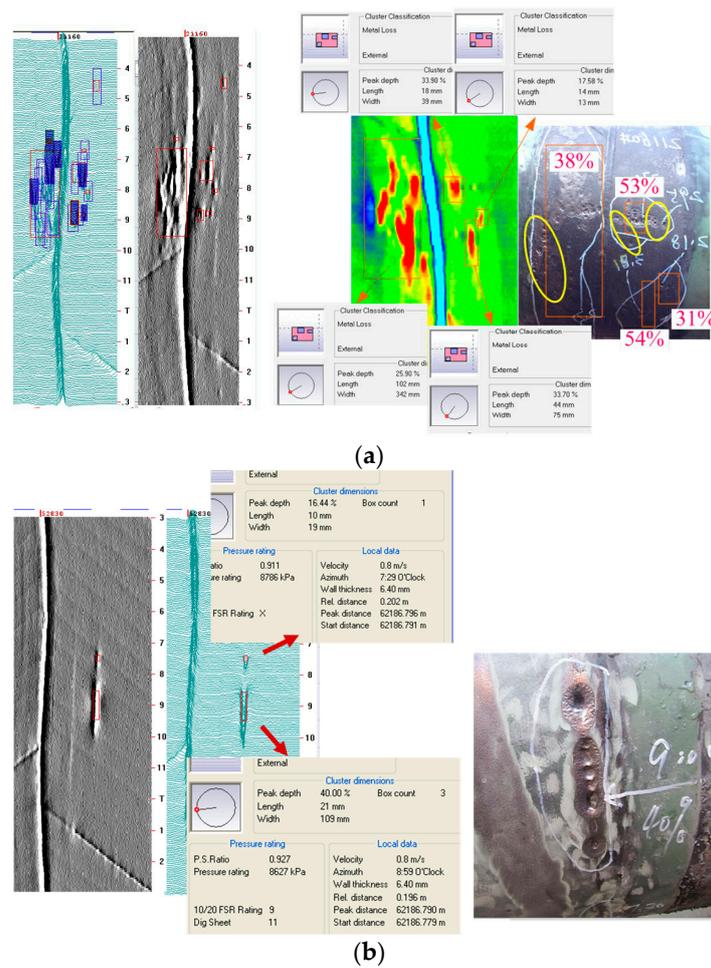
Type 1: Defects cluster in patches or strips, or one single corrosion depth is more than 30 wt %. This type is the most likely failed FJCs. Typical picture is shown in Figure 11.

Figure 11. Typical signals and excavation pictures for type 1. (a) Excavation results of defect with peak depth of 33.9 wt %; (b) Excavation results of defect with peak depth of 40.4% WT.

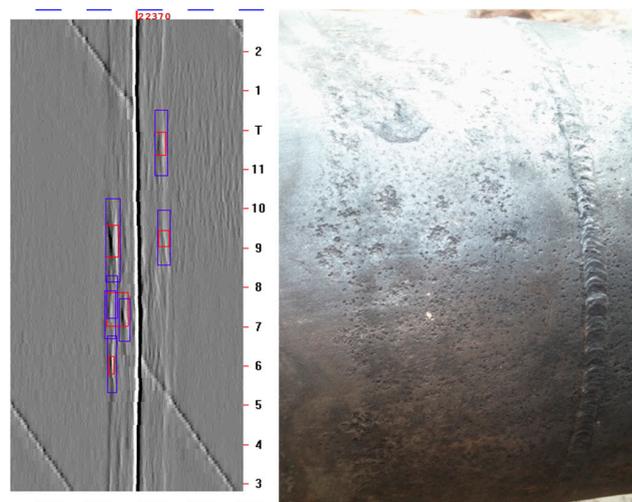
Type 2: Circumferential length of defect (signal or combined) is above 40 mm with depth above 5 wt %. Typical picture is shown in Figure 12.

Figure 12. Typical signals and excavation pictures for type 2.

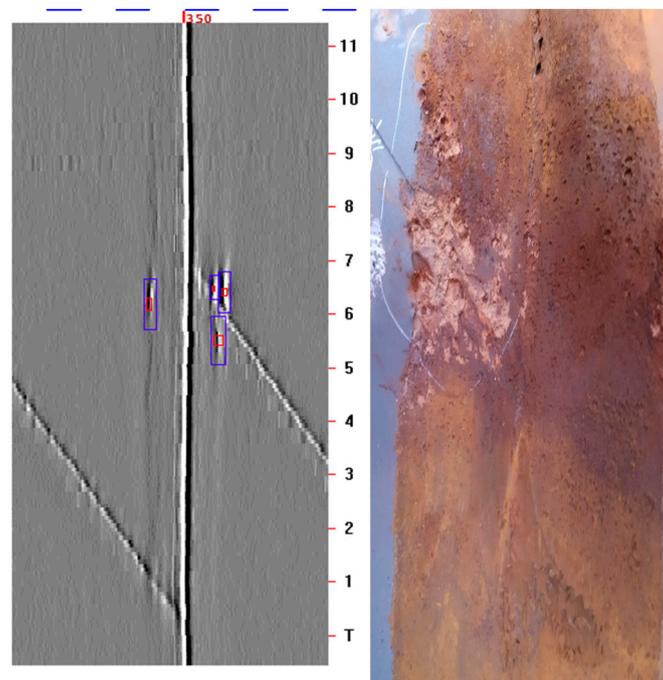
Type 3: Defects are dispersed, but there are riverside pattern lines appearing in the FJC regions of gray-scale signals with at least one defect's depth above 5 wt %. Typical picture is shown in Figure 13.

Figure 13. Typical signals and excavation pictures for type 3.
