# Construction Technologies and Conservation Strategies for the Bell Tower of Former Nanking University (Nanjing, China)—A Case Study of a Typical Architectural Heritage of the American Church School in the Late 19th Century

**Abstract:** The bell tower of Nanking University, built in 1888, is a milestone of modern educational architecture in Nanjing. It fully introduced Western architectural concepts and is an important historical witness to the cultural exchange between China and the West. At present, there are few studies on the conservation and reuse of the building, so the authors conducted the project. In this paper, we conducted research by combining qualitative and quantitative methods. The qualitative analysis includes analyses of historical maps, photos, text, surveys, mapping of buildings, and a comparative analysis. The quantitative analysis includes statistics on the distribution of the urban school architectural heritage, the number of buildings at Nanking University, and China's school building design standards. Through the historical research and value analysis of the building, we explore its real information from the aspects of architectural style, space, structur

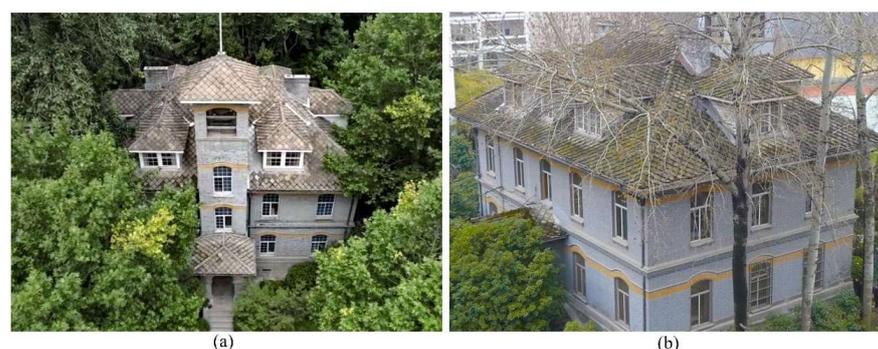
**Figure 6.** Current photos of the bell tower (source: author). (a) Bird's-eye view of the bell tower from south to north. (b) Bird's-eye view of the bell tower from the northwest.

When the bell tower was first built, the main structure was three floors. After the fire in September 1917, it changed to two floors. The original third floor was changed to an attic with dormer windows. The original flat roof was changed to the sloping roof. The tower was originally five floors but was later changed to four floors. At present, The architectural form of the bell tower is slightly damaged, and its architectural style is the American colonial style (Figures 5 and 6).

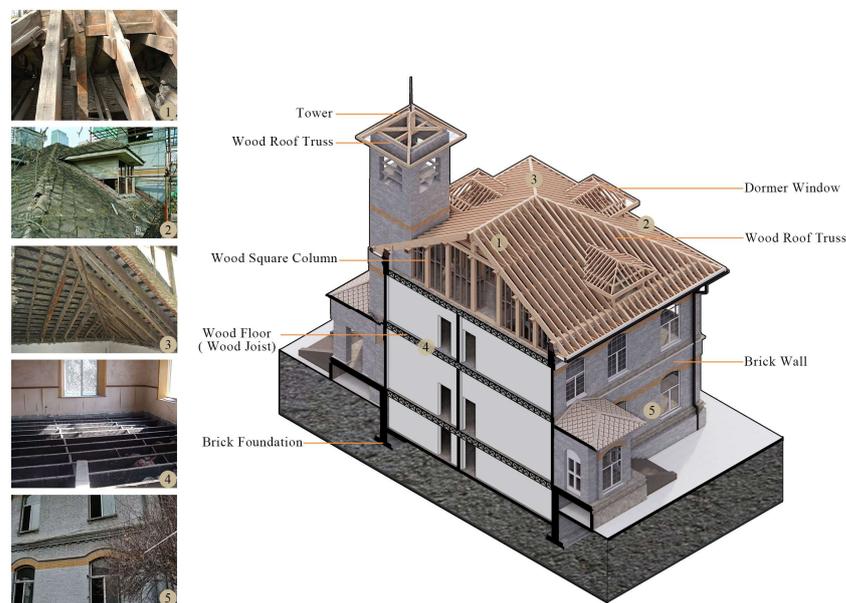
The building is a brick and wood structure. The exterior walls are built with clay bricks, the interior walls of the first and second floors are brick walls, and the interior walls of the third floor are wooden. Roof trusses, stairs, floors, and joists are all made of wood (Figure 7). At present, the building has some damage, for example, some walls are damaged or cracked, some roof tiles are falling off, many windows are missing, many window sills are damaged and a large number of drainage pipes are seriously damaged, which are in urgent need of repair (Figure 8). According to the “Safety Appraisal Report of the bell tower of the Nanking University” [29], the structural system needs to be strengthened.

**Figure 7.** The structure of the bell tower (source: author).

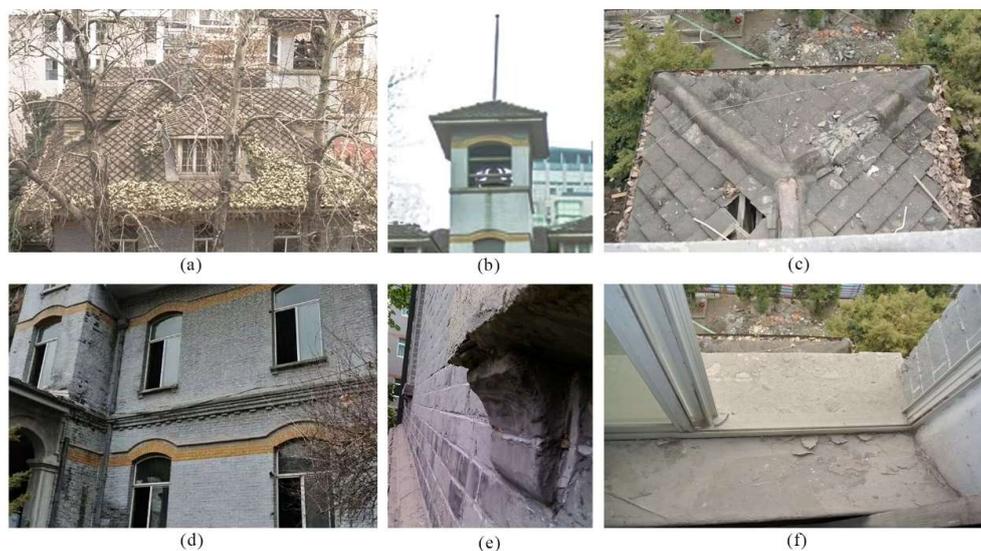
**Figure 8.** Damaged state of the bell tower (source: author). (a) Damaged roof (b) Damaged tower walls (c) Broken tile (d) Broken south wall (e) Broken wall detail (f) Broken window and window sill.

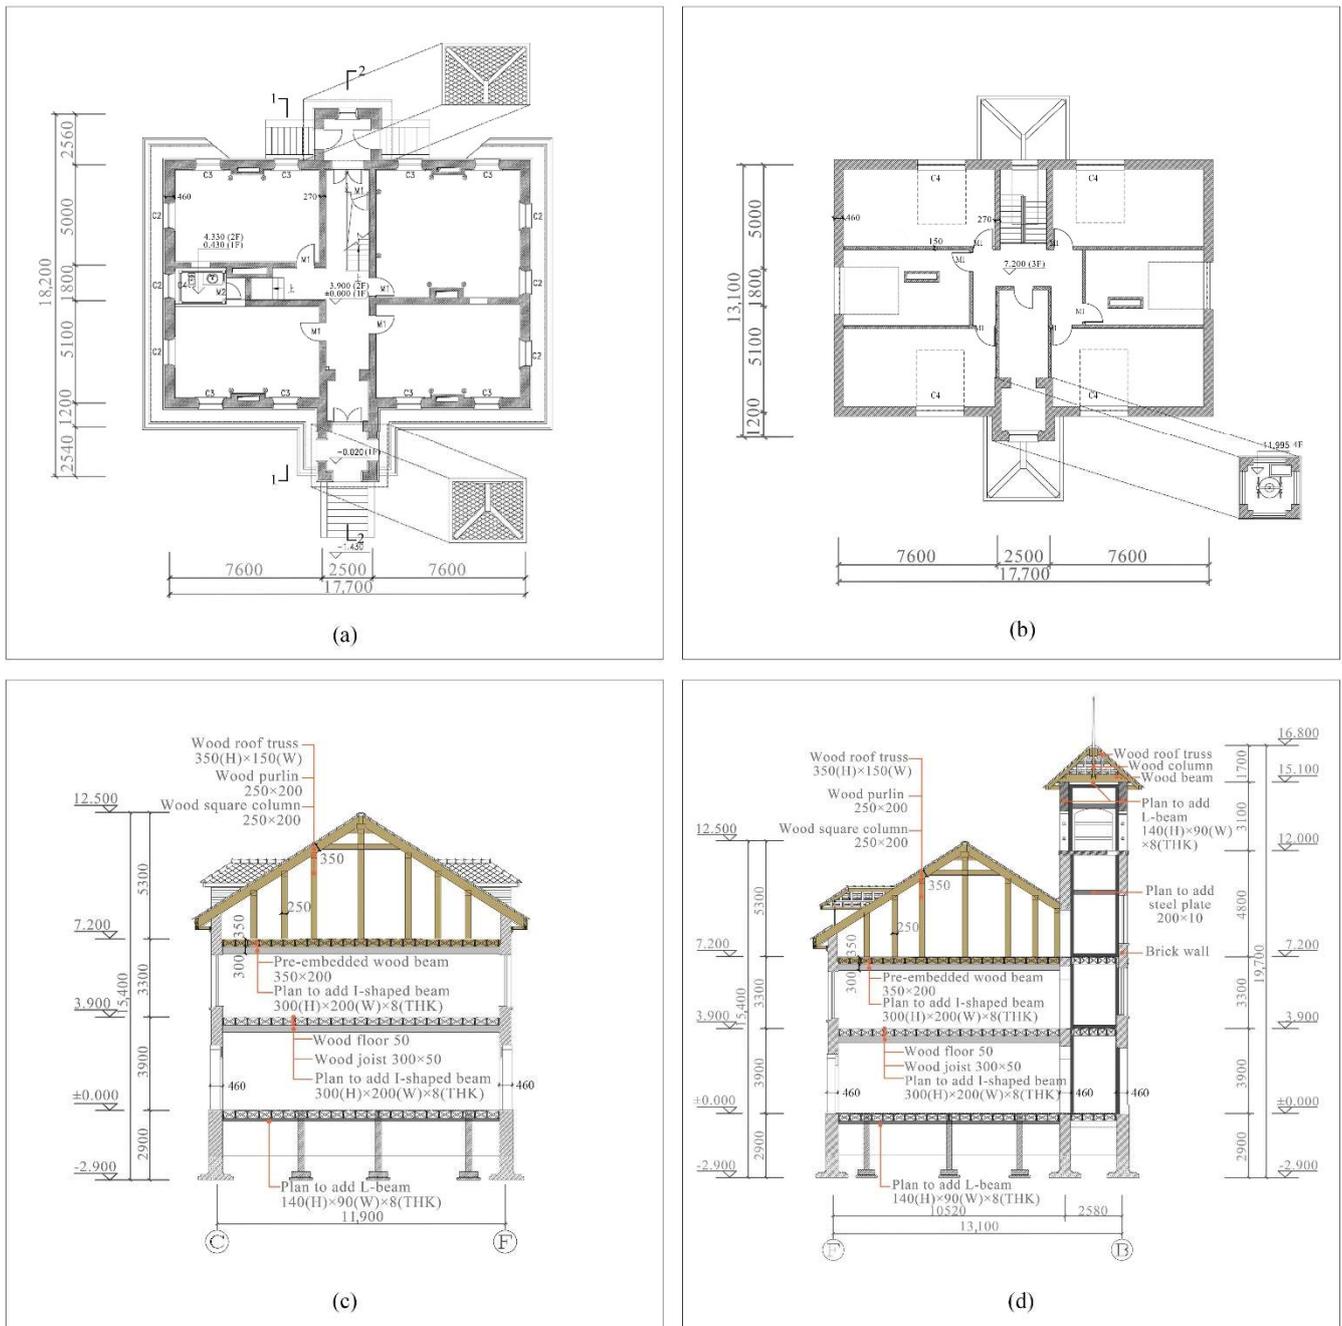
The building is a brick and wood structural system. Wood roof trusses, wood purlins, wood-square columns, wood beams, wood joists, brick walls, and brick foundations constitute the load-bearing structural system of the building. In order to increase the stability of the structural system, wood beams are pre-embedded in the surrounding exterior walls to connect with the wood roof trusses. On the third floor, the pre-embedded wood beams are connected to the bottom of the wood-square columns (Figure 10).

The structural elements of the building are described as follows: the brick foundation is in the form of spread footing, the thickness of the exterior brick wall is 460 mm, and the thickness of the interior brick wall is 270 mm (Figure 10a,b). The walls are built with grey clay bricks and white lime mortar. The first to third floors are all wood floors with wood joists. The thickness of the wood floor is 50 mm. The height of the wood joists is 300 mm, the width is 50 mm, and the spacing is 500 mm. At present, a small number of wood joists are rotted and cracked, and we plan to add I-shaped beam strengthening at the bottom of the wood joists. After the mechanical calculation, the reasonable I-shaped beam size is

selected according to the space scale. For example, when the span is 6.8 m, the height of the I-shaped beam is 300 mm, the width is 200 mm, and the thickness is 8 mm; when the span is reduced, the size of the I-shaped beam is also reduced. The third floor is the attic. In order to reduce its own weight, wood roof trusses, wood purlins, and wooden pillars are used. The bottom of the pillars is connected with the pre-embedded wood beams in the wood joists, and the wood roof trusses are connected with the surrounding external walls, which together form a structural system (Figure 10c,d). The thickness of the interior walls of the attic is 150 mm; they are wooden walls and are used to separate rooms (Figure 10b), not a structural system [31].

**Figure 10.** Structural elements of the bell tower (source: author). (a) The first and second floor plan (b) The third floor plan. (c) Building structure element (1–1 section diagram) (d) Building structure element (2–2 section diagram).

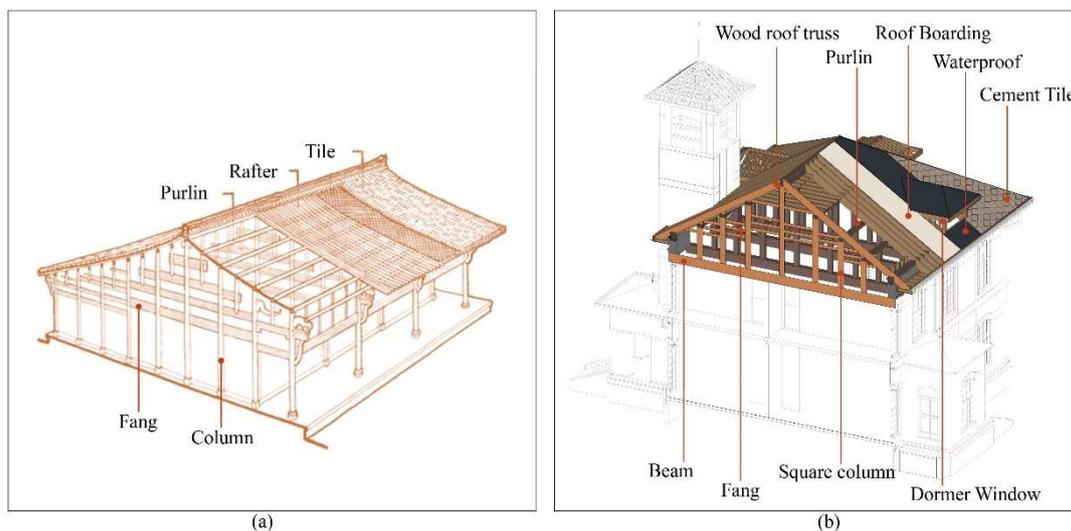
Because Chinese craftsmen participated in the construction, the roof truss is similar to the “cross type wood structure”. It is a typical structural system of traditional Chinese architecture. Its characteristic is that the columns are erected along the depth direction of the house, and the spacing between the columns is relatively dense. Along the direction of the purlins, the columns in series with fangs (small beams) are connected. This forms an overall structural system [34] (Figure 11a).

**Figure 11.** Comparison of the Chinese traditional roof-truss system and bell tower roof-truss system (source: author). (a) Chinese traditional roof-truss system “cross type wood structure” (b) Bell tower roof-truss system.

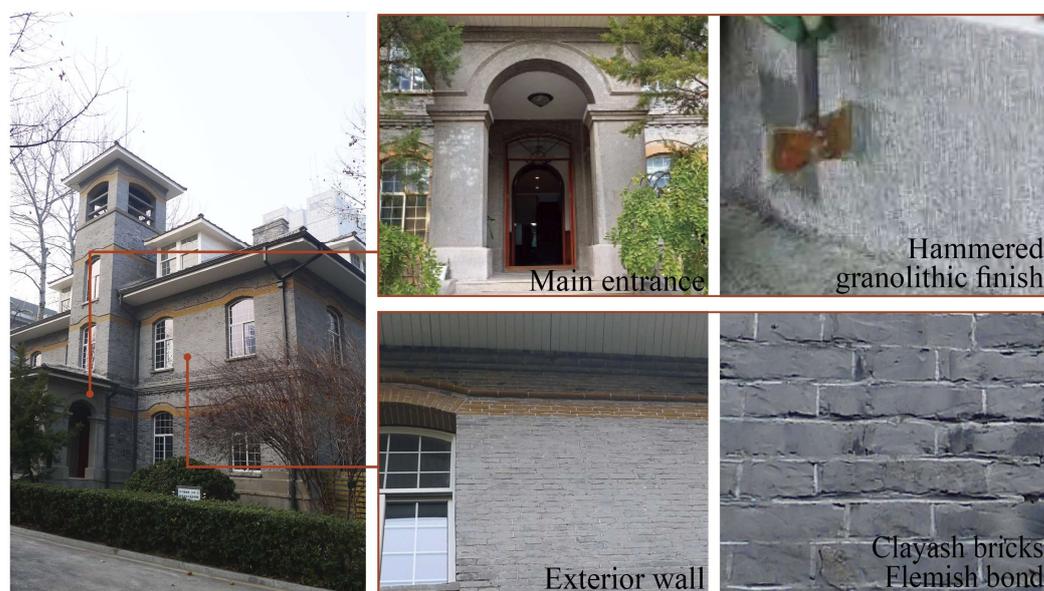
In terms of building materials, the building's foundation and walls were built with local clay-ash bricks. It embodied the wisdom of construction according to local conditions. The masonry method of the brick wall was Flemish bond. They used white lime mortar for jointing. When the building was first built, the exterior walls were all made of clay-ash bricks. In daily use, the outer wall from the outdoor ground to the first window sill was often wetted by rainwater. Therefore, when repairing, we brushed a layer of cement mortar on the surface of the clay brick as a waterproof layer [35]. To accentuate the main entrance, the surface of the brick porch was covered with a hammered granolithic finish. It is a kind of artificial stone (Figure 12). During production, cement mortar mixed with stone chips and stone powder was applied to the surface of the building. After hardening, the mixture was made into a textured stone surface style by cutting and chiseling. They are widely used in modern China in important public buildings.

**Figure 12.** Materials and construction technology (source: author).

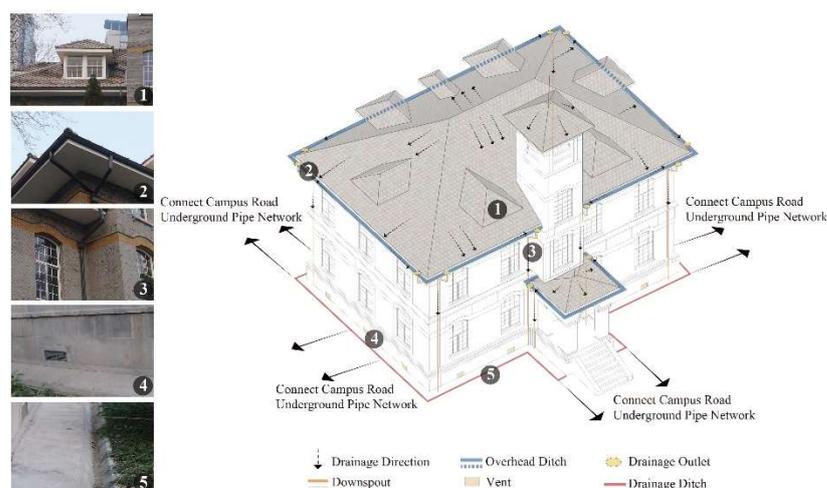
Figure 13. Water drainage system (source: author).

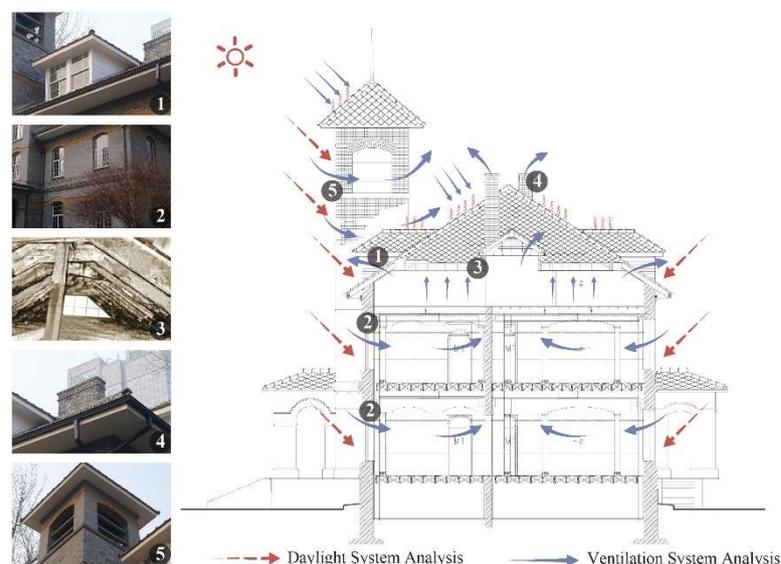
The building focuses on natural ventilation. Since the dominant wind direction in Nanjing is the southeast wind in the summer and the northwest wind in the winter, the building is arranged facing south, with porches on the south and north sides, windows all around, dormer windows on all sides of the roof, and ventilation holes in the basement to form a natural ventilation system (Figure 14). Under well-ventilated conditions, the wood roof trusses, wooden pillars, and wooden stairs can be air-dried in time even if they are temporarily damp, and there is no major decay after more than one hundred years.

Figure 14. Ventilation system (source: author).

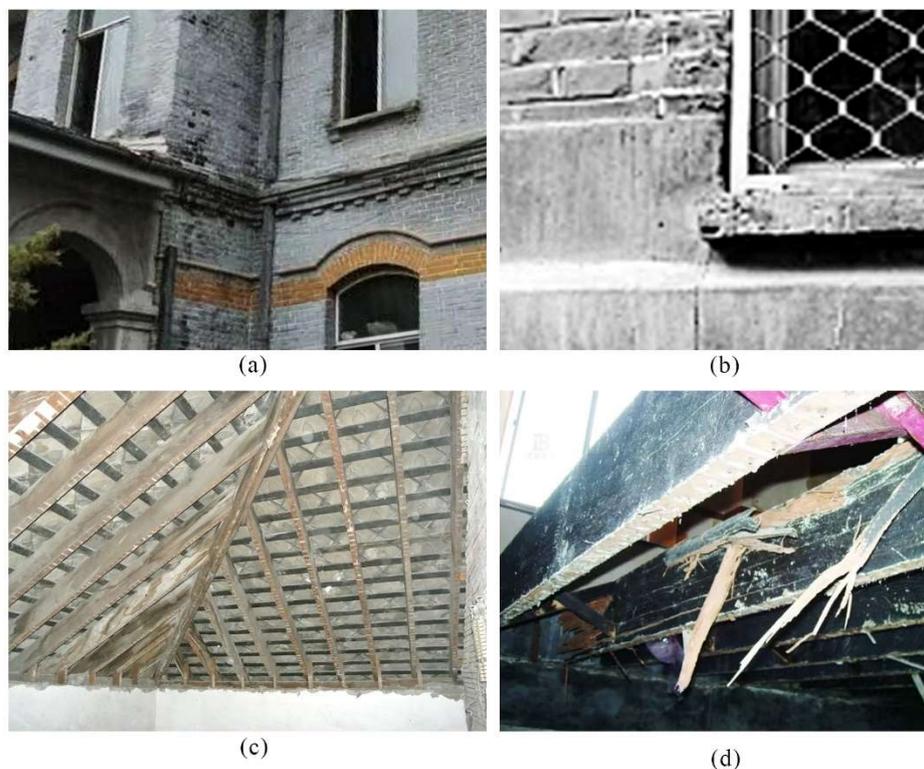
The first is to examine the general condition of the structure. The building has no obvious uneven land subsidence, no cracks in the foundation, and no cracks in the superstructure caused by uneven land subsidence of the foundation. Wall materials are clay bricks and lime mortar. At present, the quality of the bricks is still good, but some exterior walls are damaged due to dampness and weathering (Figure 15a), and a small number

of windows have oblique cracks at the corners (Figure 15b). Therefore, the load-bearing capacity of the walls is basically acceptable based on a small number of structural cracks and material degradation assessments. Currently, small numbers of wood joists and trusses are rotted or cracked (Figure 15c,d).

**Figure 15.** Damaged state (source: author). (a) Damaged exterior walls (b) Cracked window corner (c) Rotted wood roof trusses (d) Cracked wood joists.

To summarize, according to the assessment results of the foundation and the upper load-bearing structure, the safety level of the building is assessed as the  $C_{su}$  level [41]. Some dominant members, such as walls, wood joists, and wood roof trusses must be strengthened due to material degradation. In addition, the building did not consider earthquake resistance in its previous design, and its structural integrity and earthquake resistance were poor. It should be combined with repairs and seismic strengthening to basically meet China's current codes.

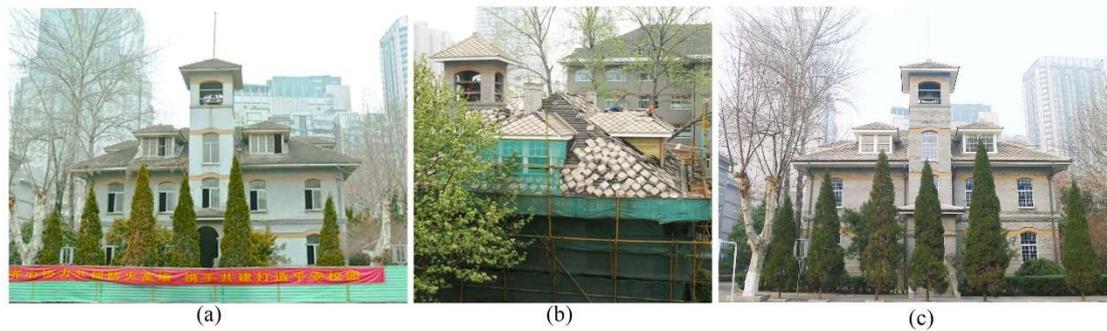
**Figure 19.** Photos of the bell tower before, during, and after repairs (source: author). (a) Before conservation. (b) Renovation in progress (c) After conservation.

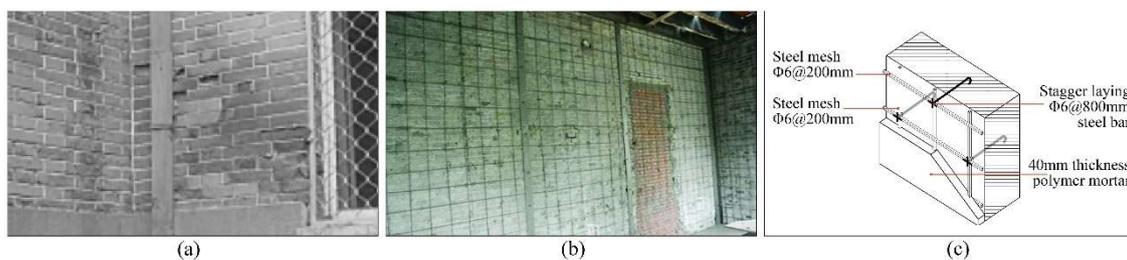
The bell tower was built more than one hundred years ago, and some materials have degraded. According to on-site inspections, some exterior walls were damaged (Figure 20a), and oblique cracks appeared in some window corners. Since the earthquake resistance was not considered in the design at that time, the overall earthquake resistance of the structure was poor. Therefore, we attach great importance to the maintenance of the wall to ensure its integrity, and strengthen the bearing capacity and integrity of the wall to improve its load-bearing capacity and ductility to deal with earthquake risks (Figure 20b).

**Figure 20.** Wall strengthening (source: author). (a) Damaged exterior walls (b) Strengthening in progress (c) Wall strengthening methods.

A pressure pump was used to inject a cement slurry to seal the cracks in the wall. The broken brick walls were repaired to ensure wall integrity and improve the load-bearing capacity. Clay bricks adopt different repair methods according to the damage depth; when the damage depth of the brick is less than 10 mm, it will not be repaired, but only cleaned and protected. When the damage depth of the brick is 10–20 mm, it should be repaired with brick powder. The brick powder material has good compatibility with the original wall, and the color is similar to the original wall. After adding water and mixing well, an appropriate amount of adhesive was added, the damaged part of the wall was repaired, and then the mortar joints were filled. When the damage depth of the brick is greater than 20 mm, the damaged surface will be cleaned and repaired with brick bat.

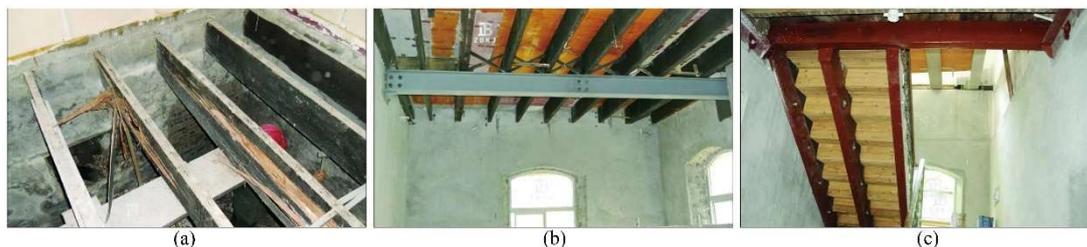
A small number of wood joists were cracked (Figure 21a) and needed strengthening. We first applied water-resistant glue to the two cracked surfaces, then used more than two steel hoops to hoop the cracked wood joists, and finally wrapped them with CFRP to secure them. Considering that the two ends of the wood joists were embedded in the wall for a

**Figure 21.** Wood joists and wood stair strengthening (source: author). (a) Broken wood joists (b) Wood joists strengthening (c) Stair strengthening.

long time and are easy to rot or loosen after deformation, we strengthened the ends of the wood joists with L-section steel. The height of the L-section steel was 120 mm, the width was 90 mm, and the thickness was 8 mm. Not only does this increase the lengths of support at the ends of the wood grating, but it also forms a steel ring beam on the wall [47].

After the renovation, the building will serve as a school history museum and club and will be visited by a large number of people. We set the standard value of the live load of the wood floor as  $3.5 \text{ kN/m}^2$  (according to the Chinese standard “Building Structure Load Code (GB50009-2012)”), and according to the structural calculation, the wood joists need to be strengthened as a whole. We added steel beams along the vertical direction of the wood joists in the middle of the room span for strengthening. The I-shaped beam height was 300 mm, the width was 200 mm, and thickness was 8 mm (Figure 21b).

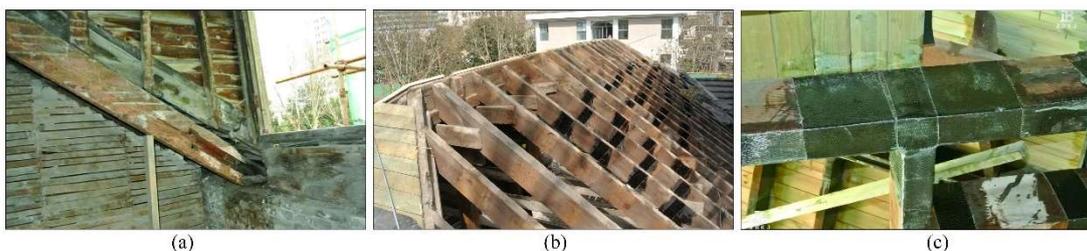
- (1) The rotten parts of the wood roof truss were replaced. Some wood roof trusses had rotted ends (Figure 22a). We sawed off the rotten parts and used the original wood to redo this place. First, we used water-resistant glue on the joint surface of the old and new materials. Then we used two pieces of anti-corrosion wood to clamp the old and new wooden components; we then used water-resistant glue to fasten and screw the bolts. Finally, we used CFRP to strengthen the wooden components and wrap the old and new materials tightly.

**Figure 22.** Wood roof truss strengthening (source: author). (a) Broken wood roof truss (b) Roof truss strengthening (c) Roof truss joints strengthening.

- (2) For cracked roof trusses, CFRP was used to enhance durability in a circular direction. The thickness of CFRP was 0.167 mm, the paving width was 100 mm, and the interval was 400 mm (Figure 22b).
- (3) CFRP paste strengthened the joints of the beams, purlins, and columns to enhance the integrity of the wood roof truss (Figure 22c).

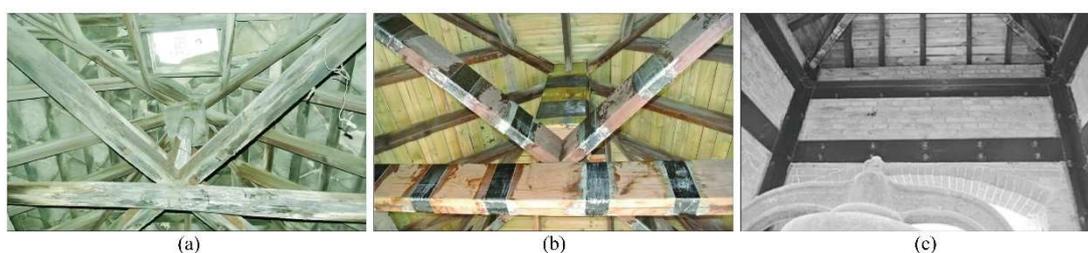
**Figure 23.** Tower strengthening (source: author). (a) Broken tower roof truss (b) Tower roof truss strengthening (c) Tower wall strengthening.

The wood columns under the roof of the tower were strengthened with CFRP. The tower was much taller than the main building, which was prone to the whiplash effect during an earthquake and required seismic strengthening. We added L-shaped steel on the inner side of the tower wall to form structural columns and ring beams, which improved the integrity and earthquake resistance of the building and weakened the whiplash effect without affecting the appearance of the building [48] (Figure 23).

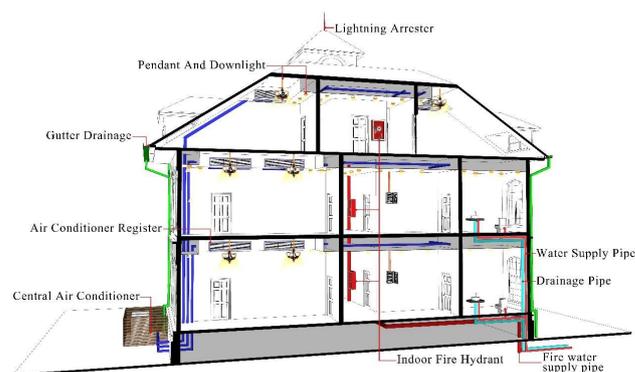
**Figure 24.** Renewal strategy of construction equipment (source: author).

First, repair the existing drainage and power supply system, including the roof waterproofing and gutters, and replace drains, electrical wiring, and lighting.

Then, according to the needs of the new users, add fire hydrants, lightning conservation belts, and air conditioning systems. Install fire hydrants in corridors, roof lightning conservation belts at the eaves and ridges of the buildings, 20 m × 14 m lightning conservation nets on the roof, strengthen the steel columns as lightning conservation down conductors, and use the building foundation steel bars as grounding devices. Adopt a VRV small central air-conditioning system, and hide the air-conditioning unit in the green belt around the building (Figure 24).
