# Experimental Investigation on Structural Performance Enhancement of Brick Masonry Member by Internal Reinforcement

**Abstract:** This study focused on perforated bricks, and the structural performance enhancement of brick members by internal reinforcement was experimentally investigated. As a new reinforcing material, screw iron (SI) rods were selected for the internal reinforcement, and they were inserted into the perforated brick. To investigate the most-effective reinforcing method as well as to understand the fundamental structural behaviors, four specimens with different variables were fabricated, and three-point bending tests were carried out. From the experiments, it was found that the maximum strength of the specimen increased by more than two times with internal reinforcement. The internal reinforcement, fixed by nuts at both ends of the specimen to enhance integrity, increased the maximum strength by nine times. Moreover, the deformation capacities of the specimens were also greatly enhanced. The case where the internal SI rods were fixed by nuts without mortar also showed a similar structural performance to the case with mortar. The estimation methods of the maximum s

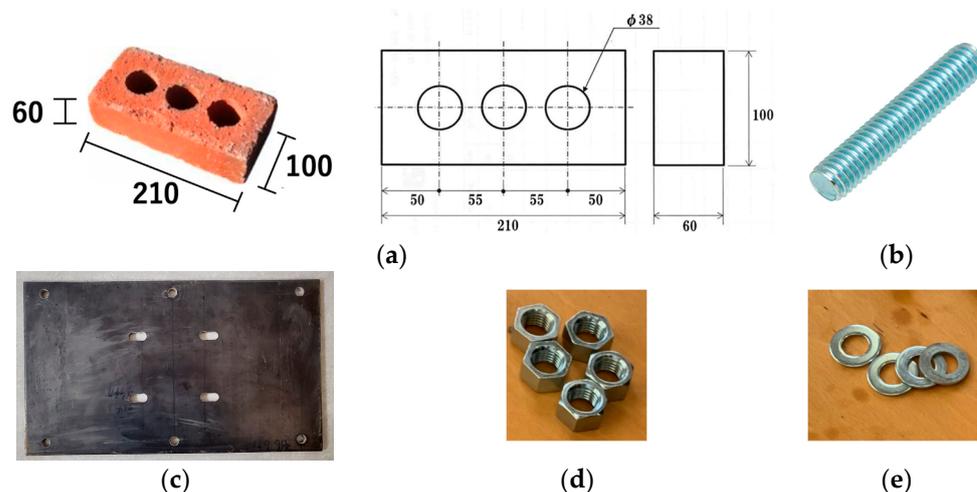
**Figure 5.** Selected material in this study: (a) Perforated brick (mm); (b) Screw iron rod (M14); (c) Steel end plate; (d) Nut; (e) Washer.

Figure 5 shows an overview of the materials selected in this study. As shown in the Figure, a screw iron (SI) rod was employed as a new reinforcing material. Perforated bricks with three holes, produced in Japan, were employed in this study since the local products of the region of South East Asia were not available. It was noted that the main purpose of this study was the application of SI rods to perforated bricks and the investigation of the internal reinforcing effects on structural performance; therefore, the perforated bricks from Japan were adopted at this time. The mortar mix proportion of sand, cement, and water was 11:1:1 (weight ratio). In addition, in order to solve the problem of the integrity and bonding behaviors between the steel bars and mortar, which were raised in the previous study by the author [49], the use of deformed reinforcing bars with screws (threaded reinforcing bars) was first considered. By fixing the bricks at both ends using screw reinforcing bars and nuts, it was thought that the integrity of the members as well as the bonding between the reinforcing bars and mortar could be assured. On the other hand, SI rods, which were

easily available compared to screw reinforcing bars, were selected as a new reinforcing material. Hence, M14 with a nominal cross-sectional area of  $115 \text{ mm}^2$  was used for the SI rods, and the steel plate was attached to both ends of the brick member in some specimens, as explained later. It was noted that the thickness of the steel plate (9 mm) was selected after examining the bearing pressure of the nut and the safety against the punching shear.

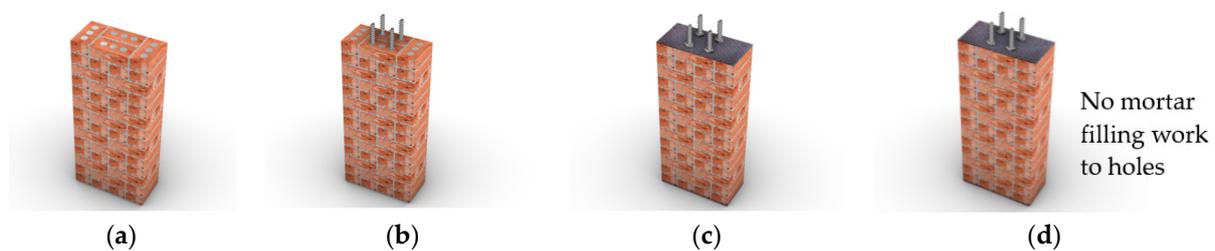
**Figure 6.** Conceptual diagram of test specimens: (a) UBM; (b) IRBM; (c) IRBM—F; (d) IRBM—FNM.

Figure 6 shows a conceptual diagram of the test specimens. Four specimens were fabricated in total. First, the UBM (Unreinforced Brick Member) specimen consisted of perforated bricks and mortar without any reinforcement, and, in the IRBM (Internally Reinforced Brick Member) specimen, an internal reinforcement of four SI rods was added. From these two specimens, the internal reinforcing effect of the SI rods was examined. Next, in the IRBM—F (Internally Reinforced Brick Member Fixed by nut) specimen, the four SI rods were fixed by nuts after sandwiching both ends of the specimen with steel plates to enhance integrity. As mentioned earlier, according to the previous test results [49], the flexural strength of the specimen increased when the bonding performance between the steel and mortar was sufficiently secured. Therefore, in order to enhance structural performance, fixing work with steel plates and nuts was introduced. It was noted that every hole of the perforated brick was filled with mortar in IRBM—F. On the other hand, the mortar filling work to the holes was omitted in the IRBM—FNM (Internally Reinforced Brick Member Fixed by nuts with No filling Mortar) specimen to further improve workability as well as to save on costs and materials. The internal SI rods were fixed by nuts at both ends of the specimen, and the joint mortar was only employed on each layer between bricks in the IRBM—FNM.

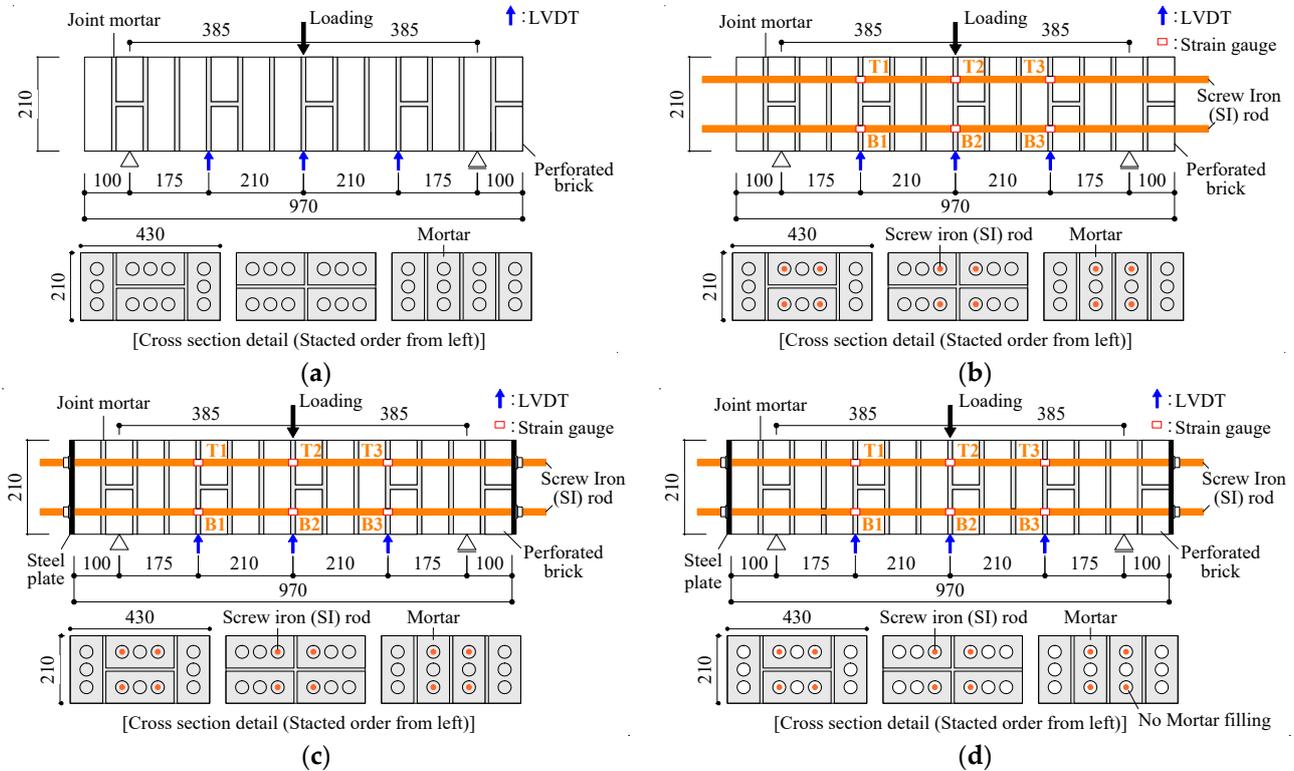
Figure 7. Specimen and experiment details: (a) UBM; (b) IRBM; (c) IRBM—F; (d) IRBM—FNM (mm).

The specimen dimensions were 210 × 430 × 970 mm (depth × width × height), and the cross-sectional details are shown in Figure 7. As was performed in the previous experiment [49], the 3 arrangement patterns shown in Figure 7 were stacked in order for 14 layers to fabricate each specimen since such a combination arrangement was thought to provide more robust resistance against lateral loading. In order to find out the effective reinforcing method as well as to understand fundamental structural behaviors, 3-point bending tests were carried out, where the distance between two supports was set to be 770 mm, as can be seen in Figures 7 and 8. In the 3-point bending test, the vertical deflection of the specimen was measured at three points by displacement transducers (LVDTs). The strains at the crucial points of the SI rods were also measured for the specimens with internal reinforcements. It was noted that B1~B3 and T1~T3 represented the strains of the bottom and top side rods, respectively. From those strains, bond stresses between the mortars and rods were calculated to investigate the bonding performance, as discussed later in Section 3. All the specimens were fabricated by non-experts such as lab students, supposing self-buildable economic housing. In the specimens with SI rods, the rods were fixed vertically in advance, and then the masonry work was carried out by passing the perforated bricks through the rods. The bricks were stacked one-by-one, and mortar works were applied at the same time. The accuracy of the mortar filling work was likely to vary depending on the workers. Hence, it may have affected the bonding performance between the mortars and SI rods, which was the reason why the rods were fixed by steel plates and

nuts in IRBM—F and IRBM—FNM. It was also noted that the ends of the SI rods were lightly tightened with nuts using human power after curing the mortar; thus, the initial prestressing force was little.

where  $\sigma_T$  is the mortar tensile strength by splitting test shown in Table 1 (0.9 MPa in this study),  $Z$  is the section modulus, and  $l$  is the distance between both supports shown in Figure 7 (770 mm in this study).

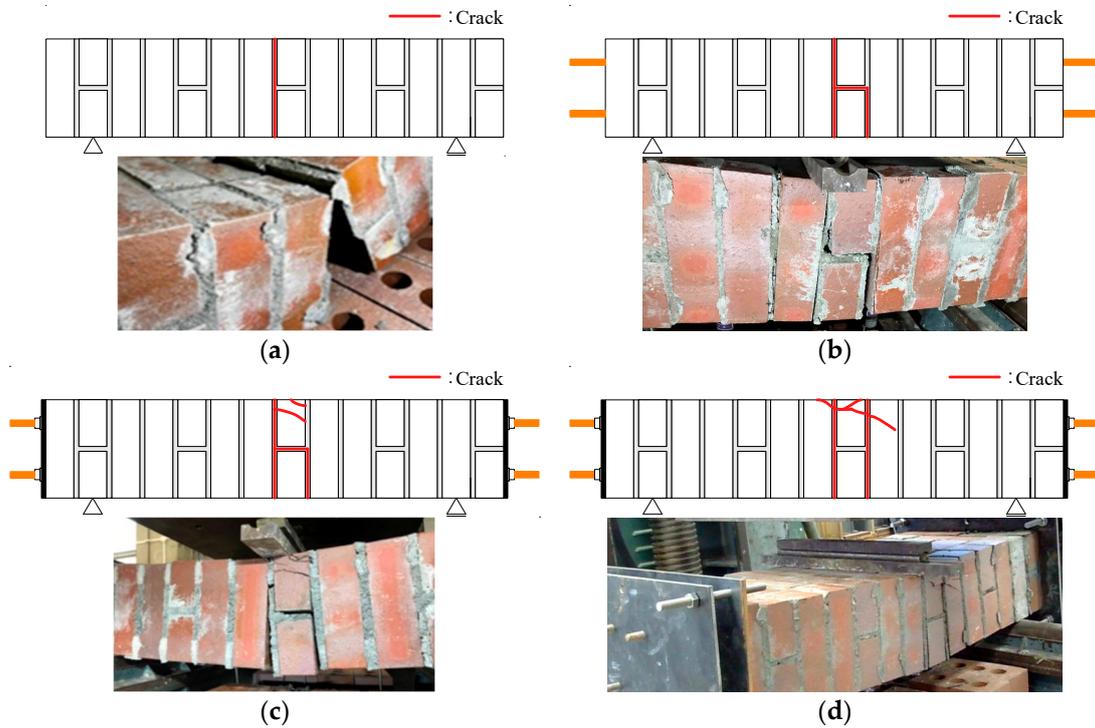
Figure 9. Crack patterns: (a) UBM; (b) IRBM; (c) IRBM—F; (d) IRBM—FNM.

Figure 9a shows the final failure pattern, and the red line represents the main crack developed in the specimen. Figure 10a shows the vertical load–deflection relationship, in which the horizontal axis represents the vertical deflection at the center of the span. In this specimen, the load increased almost linearly up to a maximum strength with the increase in the vertical deflection. However, a flexural crack developed in the joint mortar at the center of the span, and a sudden brittle failure occurred. As can be seen in Figure 10a, the maximum strength recorded in this specimen was 13.96 kN, and the vertical deflection at the maximum strength was 0.26 mm. By defining the deflection angle ( $R$ ) as the ratio of vertical deflection to the half span, the failure  $R$  was only 0.068%, which exhibited poor deformation capacity. Therefore, sufficient deformation capacity cannot be expected

In this specimen, the internal reinforcement by SI rods was supplemented. Figure 9b shows the final failure pattern, and Figure 10b shows the vertical load–deflection curve. As the vertical deflection grew, a flexural crack occurred near the middle of the span, but there was no sudden strength drop, such as in the UBM. Although the flexural crack occurred, the specimen maintained a continuous strength increase to some extent, and the strength reached its maximum when the flexural crack completely progressed up to the extreme compression fiber of the damaged section. A maximum strength of 27.08 kN was recorded, which was about twice that of the UBM; in addition, the vertical deflection was 2 mm, which was greater than 7 times that of the UBM. After that, a sharp strength drop initiated just after the complete crack was opened, but approximately 40% of the maximum strength was maintained until the vertical deflection of 40 mm. At this time, a slight compression failure occurred, and damage was found on the joint mortar at the extreme compression fiber, but a stable residual strength was kept due to the SI rods and their bending resistance.

In this specimen, the SI rods were fixed by nuts after sandwiching both ends of the specimen with steel plates to enhance integrity. Figures 9c and 10c show the final crack pattern and the vertical load–deflection relationship, respectively. The yielding point of the bottom side rod is plotted in Figure 10c. In this specimen, stiffness degradation was observed after flexural crack development, and a significant stiffness decrease was found near the yielding point of the rod, which was a behavior quite similar to the reinforced concrete (RC) member. After the reinforcing rod yielded, the vertical strength gradually increased, and its maximum strength was recorded when the vertical deflection reached about 37 mm. At this time, the neutral axis depth was observed to be almost located at the extreme compression fiber of the damaged section, and the compression failure of the joint mortar and bricks was very severe. As shown in Figure 10c, a maximum strength of 126.2 kN was recorded, demonstrating more than four times the maximum

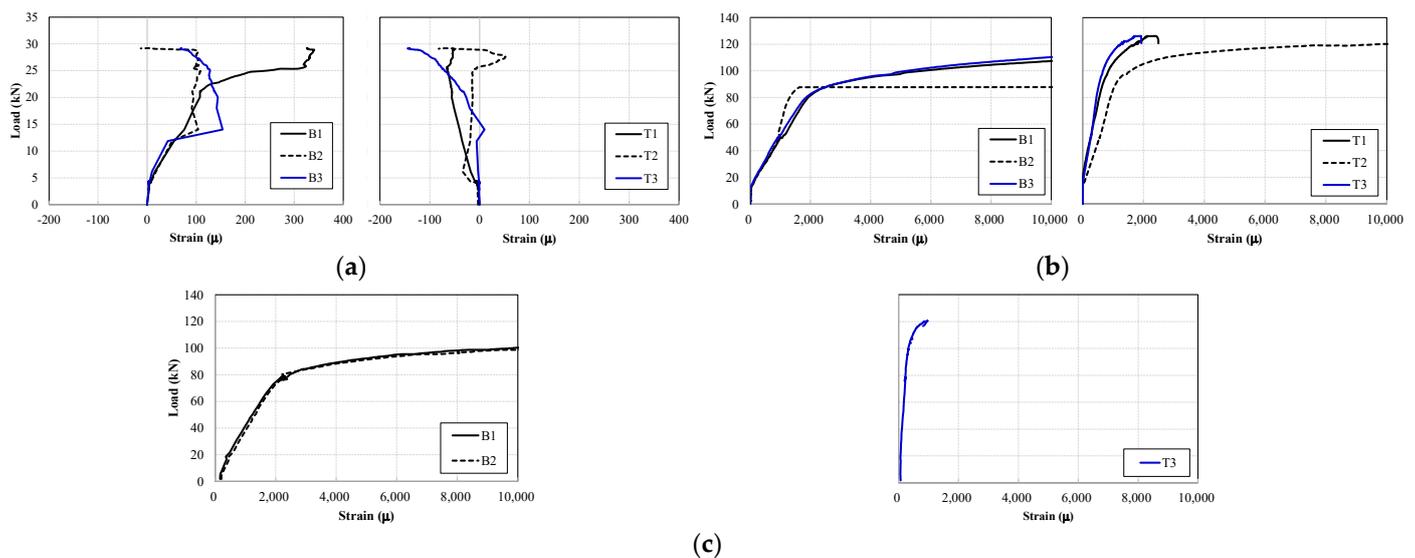
**Figure 11.** Vertical load–strain relationship: (a) IRBM; (b) IRBM–F; (c) IRBM–FNM.

Figure 11a shows the relationship between the vertical load and strains of SI rods. The strain values of the top side (T1~T3) were very small. Although those of the bottom side (B1~B3) were larger than those of the top side, the strain at the maximum strength was only about  $350\mu$ , and it was judged that the bonding condition between the rod and mortar was very poor. Comparing the extra length of the rods (See Figure 8a), which came out from the specimen before and after the test, the extra length was shortened by about 20 mm on average, which meant a slip behavior in the rods during loading.

The strain distribution of the bottom and top reinforcing rods is shown in Figure 11b. As can be found in the Figure, compared to IRBM, the strain values of the rods in IRBM—F show much larger values. All the strain values of the bottom rods exceeded the yielding strain, and the strain of T2 also yielded at the maximum strength. From the strain data, fixing the SI rods with steel plates and nuts enabled the efficient use of the reinforcement, and great performance enhancements were obtained in both the strength and the deformation capacities. It should be also noted that the compressive force was acting on the brick members as a reaction force to the tensile force of the rods as the deformation grew; therefore, it not only improved the integrity of the member but also led to an increase in shear and bending resistances.

Figure 11c shows the strain distribution of the SI rods. Some of the strain data were not measured, and only available data were plotted in the figure. The bottom rod exceeded its yield strain with the increase in vertical deflection. On the other hand, the top rod was found not to yield until the end of the loading, which was also attributed to the unbonded characteristics [50–52]. Nevertheless, compared to IRBM with no integrity by the steel plate and nuts, the strain values of the rods exhibited much higher values. Although the filling mortar inside the holes did not exist, effective use of the reinforcement and structural performance improvements could be achieved by providing the SI rods with adequate fixing conditions. As mentioned earlier, the compressive forces, which are a reaction force to the tensile force of the rods, increased as the deformations grew; thus, the integrity of the member as well as the shear and bending capacities were enhanced.

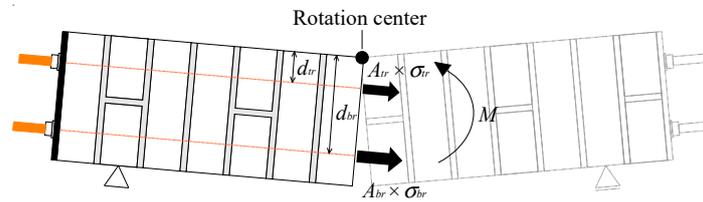
Figure 12. Force equilibrium condition.

In this specimen, from the strain data above, effective use of the reinforcement was confirmed by fixing the SI rods, which resulted in a great improvement in structural performance. As a result, the stress of the bottom rod was expected to reach its tensile strength at the maximum strength point, and that of the top rod was found to exceed its yield strength. Therefore, for the maximum strength evaluation, the stresses of the bottom and top rods were set to be the tensile ( $\sigma_t$ ) and yield ( $\sigma_y$ ) strengths, respectively, which were obtained from the material test (See Table 3). It was also noted that when the maximum strength was recorded, the neutral axis depth was very short, and the neutral axis was quite close to the extreme compression fiber of the damaged section since the cross-section had a relatively wide width (430 mm) compared to the depth (210 mm). Therefore, for simplicity, the neutral axis was assumed to be located at the extreme compression fiber, and the force equilibrium condition at the damaged cross-section was set to be as in Figure 12. The maximum strength  $Q_{max,IRBM-F}$  was then evaluated from Equations (6) and (7), where  $\sigma_t$  and  $\sigma_y$  in Table 3 were substituted for the bottom rod stress ( $\sigma_{br}$ ) and the top rod stress ( $\sigma_{tr}$ ), respectively. The calculated  $Q_{max,IRBM-F}$  was 129.43 kN and was shown together with

$$M_{max} = A_{br} \times \sigma_{br} \times d_{br} + A_{tr} \times \sigma_{tr} \times d_{tr} \tag{6}$$

$$Q_{max,IRBM-F(IRBM-FNM)} = \frac{4M_{max}}{l} \tag{7}$$

where  $A_{br}$  is the total cross-sectional area of the bottom rod (230 mm<sup>2</sup> in this study),  $A_{tr}$  is the total cross-sectional area of the top rod (230 mm<sup>2</sup> in this study),  $\sigma_{br}$  is the stress of the bottom rod,  $\sigma_{tr}$  is the stress of the top rod,  $d_{br}$  is the distance between the extreme compression fiber and the rod position on the bottom side (160 mm in this study), and  $d_{tr}$  is the distance between the extreme compression fiber and the rod position on the top side (50 mm in this study).

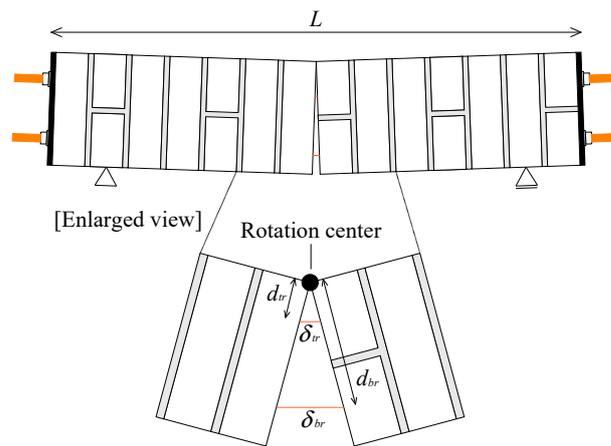
**Figure 13.** Deformation compatibility condition of IRBM—FNM with unbonded rod.

In this specimen, not only could superior workability be achieved but also a remarkable enhancement in structural performance, by eliminating the mortar filling work and the fixing of the SI rods. Due to the unbonded characteristics, the strain increment was delayed compared to that of IRBM—F. Hence, from the strain data, the stress of the bottom side rod was considered to be in the range between the yield ( $\sigma_y$ ) and tensile ( $\sigma_t$ ) strength. The strain of the top side was found to be less than the yield strain ( $\epsilon_y$ ). In addition, due to no mortar filling work, the specimen tended to rotate as a rigid body, with respect to the damaged section, after the crack development at the joint mortar. The neutral axis was very close to the extreme compression fiber at the maximum strength, as was found in IRBM—F. Based on these results, as well as considering a conservative estimation of the maximum strength  $Q_{max,IRBM-FNM}$ , the strain of the bottom rod was assumed to be  $\epsilon_y$ . Then, the deformation compatibility condition was established, as shown in Figure 13. Since the SI rod was unbonded, the total elongation of the bottom rod ( $\delta_{br}$ ) could be expressed as Equation (8). When the rotation center was located at the extreme compression fiber, the relationship between  $\delta_{br}$  and the total elongation of the top rod ( $\delta_{tr}$ ) could be derived from Equation (9). The strain of the top rod ( $\epsilon_{tr}$ ) and thus its stress ( $\sigma_{tr}$ ) could be obtained based on the material test of the SI rod. Then,  $Q_{max,IRBM-FNM}$  could be calculated from Equations (6) and (7), where  $\sigma_y$  and  $\sigma_{tr}$  are substituted for the bottom rod stress ( $\sigma_{br}$ ) and the top rod stress ( $\sigma_{tr}$ ), respectively, and the estimated  $Q_{max,IRBM-FNM}$  was 102.92 kN. The evaluated value is shown along with the test result in Figure 10d and Table 4, where the ratio of the calculation to the experiment was 0.85. Even though the estimation was slightly lower than the experiment, it showed reasonable agreement with the test result.

$$\delta_{br} = \epsilon_y \times L \tag{8}$$

$$\delta_{br} : \delta_{tr} = d_{br} : d_{tr} = \epsilon_y \times L : \epsilon_{tr} \times L \tag{9}$$

where  $L$  is the total length of the rod inside the specimen (970 mm in this study).
