## Article

# Increasing the Durability of Tools for Forest Road Maintenance

**Citation:** Vargová, M.; Bołoz, Ł.; Ťavodová, M.; Hnilica, R. Increasing the Durability of Tools for Forest Road Maintenance. *AgriEngineering* **2023**, *5*, 566–580. <https://doi.org/10.3390/agriengineering5010036>

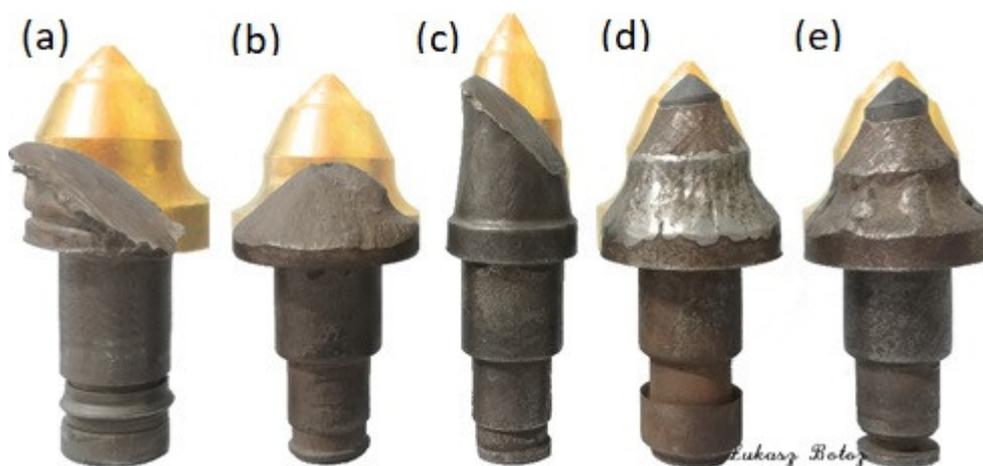
**Figure 1.** Worn conical picks [14]: (a,c) asymmetrical forms; (b,d,e) symmetrical forms.

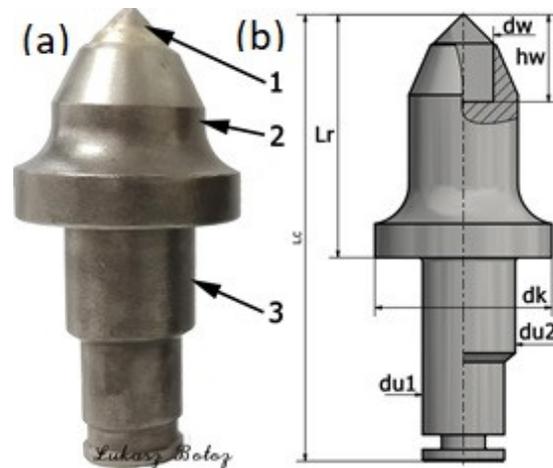
A typical conical pick has a characteristic shape. It is made in the form of a solid revolution (Figure 2a). It consists of a working part (cutting part) 2 and a gripping part 3 (mounted in pick holder). The working part is reinforced with a sintered carbide insert 1. Conical picks are mounted in pick holders with special locks. The characteristic shape of the body and the mounting method allows free rotation of picks. The rotation of picks results in even wear of the working part and the insert. Thanks to the even wear, the picks shorten but retain their shape and can properly carry out the mining process. The body of the pick and the gripping part are made of steel characterized by high impact strength (usually  $U > 25 \text{ Jcm}^{-2}$ ) and very high tensile strength ( $R_m > 1000 \text{ MPa}$ ), as well as resistance to abrasive wear. The working part should have a hardness of at least 45 HRC, while the hardness of the gripping part should be in the range of 25 HRC–35 HRC [15]. Depending on working conditions, various types of steel are applied, such as 14NC11, 41Cr4, 40NiCr6, 36CRNiMo4 or 34CRMo4 (designations according to EN 10084). In addition, the knives are subjected to heat treatment to increase their hardness and, thus, the abrasion resistance of the surface layer. Additional wear-resistant layers are made of stellites or cemented

**Figure 2.** The most common conical picks: (a) scheme of the pick, (b) dimensions of the pick: 1—WC tip; 2—body; 3 — tool shank.

In addition to the material parameters discussed above, geometric and kinematic parameters also determine the correct mining course. Below is the range of parameters of typically tapered cutters used for mining rock and other materials. The markings are shown in Figure 2b.

- Length of pick:  $L_c = 120 \text{ mm}–250 \text{ mm}$ ;
- Length of working part:  $L_r = 40 \text{ mm}–100 \text{ mm}$ ;
- Gripping part diameter:  $d_u = \phi 20 \text{ mm}–\phi 40 \text{ mm}$ ;
- Flange diameter:  $d_k = \phi 45 \text{ mm}–\phi 70 \text{ mm}$ ;
- Mounting method: Seger, HERT, expanding or friction ring;
- Insert diameter:  $d_w = \phi 10 \text{ mm}–\phi 25 \text{ mm}$ ;
- Insert height:  $h_w = 14 \text{ mm}–40 \text{ mm}$ ;
- Tip angle:  $2\beta_u = 80^\circ–95^\circ$  (more than  $95^\circ$  for ballistic shape);
- Yip shape: conical, multi-conical, ballistic, hat-shaped.

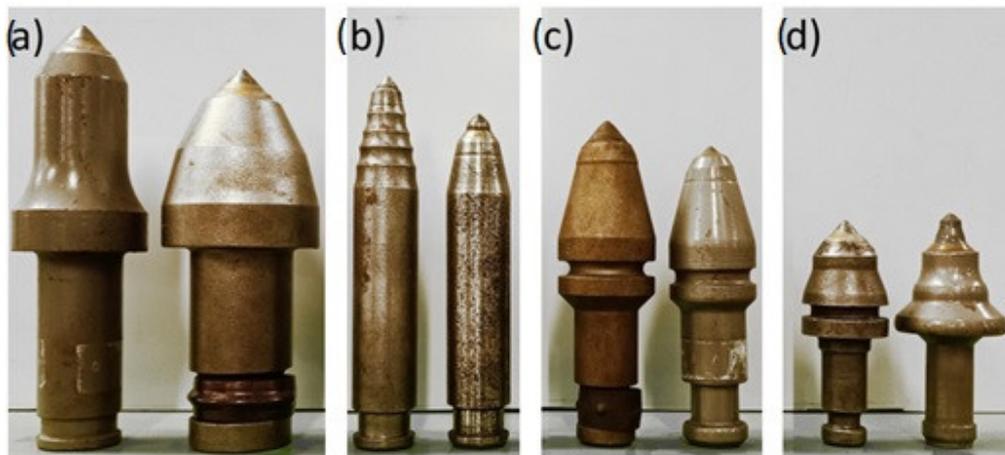
**Figure 3.** Often used types of conical picks: (a) for coals and rocks; (b) for salts; (c) for road, rocks, concrete; (d) for roads, concrete and asphalt.

Many models of picks are available on the market, differing in material and geometrical parameters, shape and assembly method. This results in the existence of more than two hundred models of picks. Shape and size depend on the type of machine, which is related to the type of cutting material and environment (Figure 3a–d).

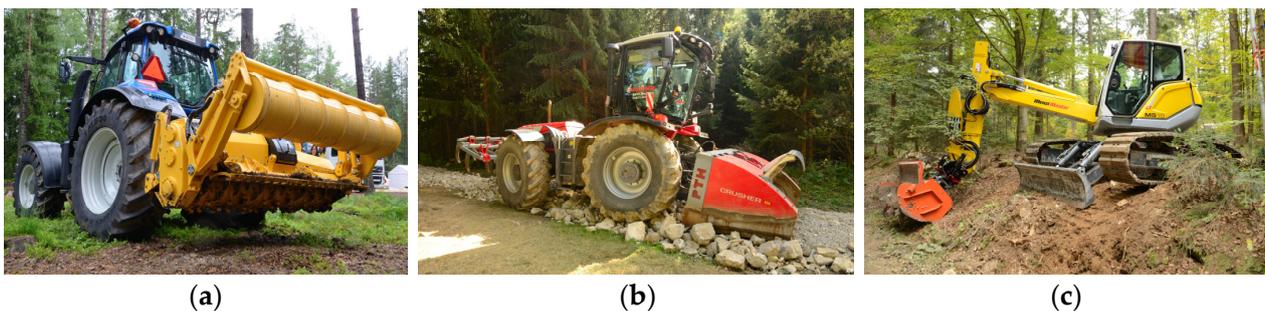
**Figure 4.** Machines for the creation, modification and reconstruction of forest roads: (a) for UKT; (b) for special machines; (c) for hydraulic manipulators.

Basic equipment for the creation, modification and reconstruction of forest roads includes adapters as additional equipment for UKT (universal wheeled tractor). Alternatively, they are designed as adapters for various special machines or mounted on hydraulic manipulators (Figure 4).

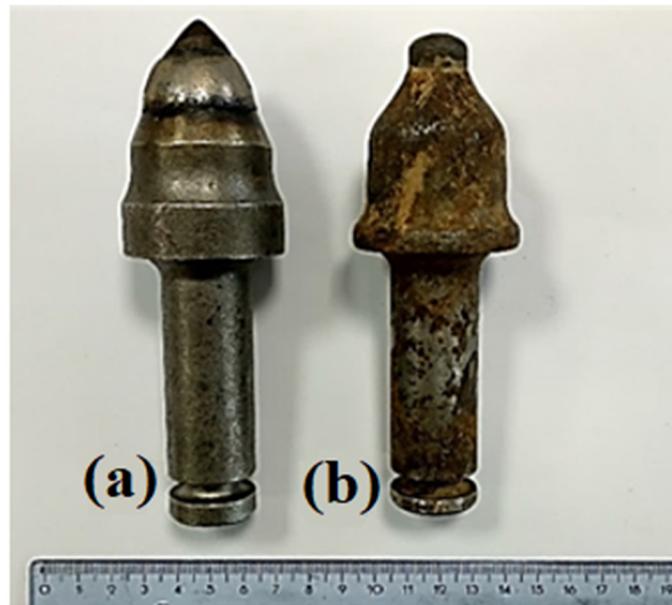
The functional surfaces of the tool are the surfaces that are most involved in stone crushing and are exposed to strong abrasion and abrasive wear. In Figure 5, we see a new (unused) tool (Figure 5a) and a worn tool (Figure 5b) that has been used in continuous operation for approximately three months. We can see that there is a change in the shape and loss of material of the wolfram carbide (WC) tip and the area under the WC tip. From

this, we can conclude that these surfaces are most involved in stone crushing. The tool had to be taken out of service after a high rate of wear.

**Figure 5.** Destruction of the working tool: (a) new tool; (b) worn tool.

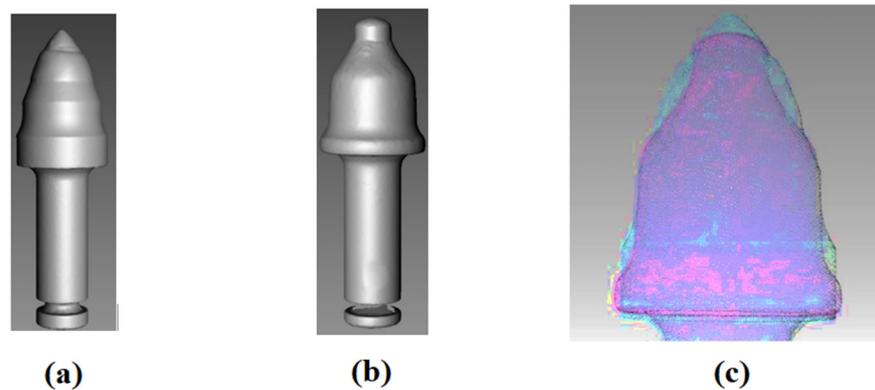
We used the visualization method to detect the wear of the working tool. With this method, a 3D image (scan) of the new (Figure 6a) and the used (Figure 6b) working tool was performed. After subsequently overlaying them, we see that there was a change in the shape of the WC tip and a loss of material below the carbide tip (Figure 6c). This also confirmed the defined functional areas of the working tool.

**Figure 6.** 3D image (scan) of the working tool: (a) 3D image (scan) of the new working tool; (b) 3D image (scan) of the working tool used; (c) overlay of the surfaces of the new and used working tool.

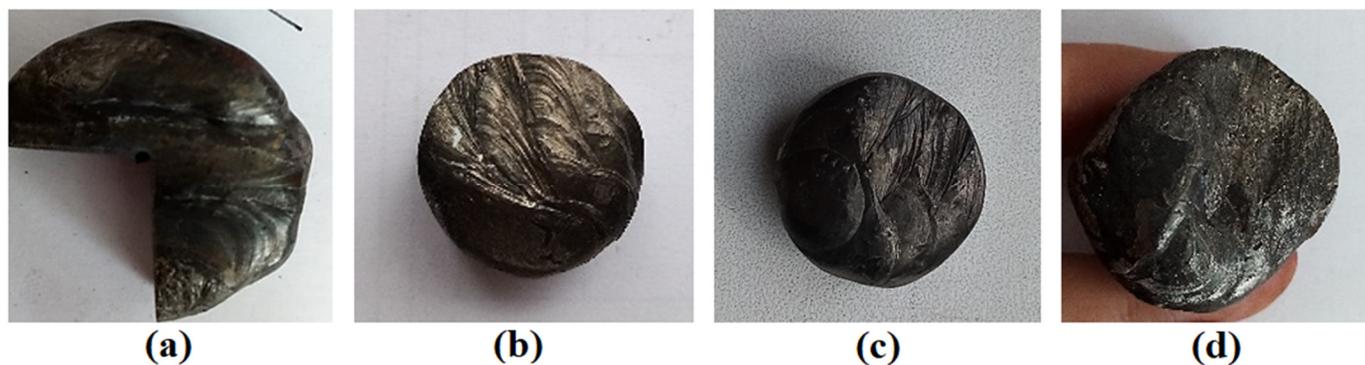
Figure 7. Samples: (a) Abradur 58; (b) E DUR 600; (c) UTP DUR 600; (d) OK 84.58.

Sample 1 (Figure 7a) was made from the hard deposit formed with the ABRADUR 58 electrode. ABRADUR 58 is an electrode from SIJ ELECTRODE JESENICE, which creates a hard layer with extreme resistance to abrasion and a moderate impact. The hard deposit is made of chrome steel. Depending on the carbon and chromium content, the hard deposit has ferritic, austenitic-martensitic and semi-ferritic structures. It is mainly used for the hardfacing by the welding of crushers, parts of earth-moving machines and soft ore crushers. The typical hardness of the hard deposit is approximately 59 [20]. The chemical composition of the electrode can be seen in Table 2. For Sample 1 (Figure 7a), the electrodes were dried in a dryer at 300 °C before hardfacing by welding. Drying took 2 h. The preheating temperature of the base material was 150 °C. The ignition of the electric arc was simple, instantaneous hardfacing by welding occurred. An electrode with a diameter of Ø 2.5 mm was used for hardfacing by welding. The hard deposit was carried out on the base material of the tool. The hardfacing by welding conditions for Sample 1 are given in Table 3.

From the hardfacing by welding with electrode E DUR 600, Sample 2 (Figure 7b) was made. E DUR 600 is a hardfacing electrode from SIJ ELECTRODE JESENICE for hardfacing by welding parts that are exposed to abrasive wear associated with impacts. The hard deposit has a higher resistance to abrasion. The electrode is suitable for the surfaces of earth-moving machine parts and crushers. It is an electrode, forming the ledeburitic structure of the hard deposit, with a low content of carbon and chromium [23]. The chemical composition of the electrode can be seen in Table 2. The hardness of the hard deposit depends on the hardfacing by welding conditions and the chemical composition of the base material. The electrodes were dried at 400 °C for one hour before hardfacing by welding. The welded tool base material was preheated to 150 °C. The electric arc was unstable during hardfacing by welding. The electrode had a fragile shell. It was welded with an electrode with a diameter of Ø 2.5 mm. From Table 3, we can see that a lot of heat was introduced during the hardfacing by welding.

Sample 3 (Figure 7c) was made from the hard deposit formed with the UTP DUR 600 electrode. The UTP electrode DUR 600 is a universal electrode from BÖHLER WELDING. The hard deposit is abrasion, pressure and impact resistant, with a typical hardness of approximately 58 HRC. It is applied to armor parts of steels, manganese steels, castings and tool steels. Mainly used for earthmoving and construction machinery parts, hammer mills, crushing jaws and cones, hammer mills, etc. It has great hardfacing properties due to its quiet arc, easy slag removal, uniform current and good weld [24]. The basic data of the electrode are given in Table 2. The base material was preheated to 150 °C. The electrodes were dried in a dryer for two hours at 300 °C. Electrodes with a diameter of Ø 3.2 mm were used for hardfacing by welding. The hardfacing by welding conditions for Sample 3 are given in Table 3.

The OK WEARTRODE electrode (OK 84.58) from ESAB was made in Sample 4 (Figure 7d). The ESAB OK WEARTRODE electrode (OK 84.58) is an electrode for the hardfacing by welding of abrasive wear-resistant functional surfaces under simultaneous impact stresses with partial corrosion resistance. It is mainly used for parts of agricultural and forestry machinery, transport equipment, etc. The resulting hard deposit is formed by a martensitic structure. Full hardness is achieved already in the first layer of the hard deposit, regardless of the cooling rate [25]. The chemical composition of the electrode can be seen in Table 2. The sample base material was preheated to 150 °C. Electrodes with a diameter of Ø 3.2 mm were used for hardfacing by welding. The electrodes were dried in a dryer for 2 h at 200 °C. The hardfacing by welding conditions for Sample 3 are given in Table 3.

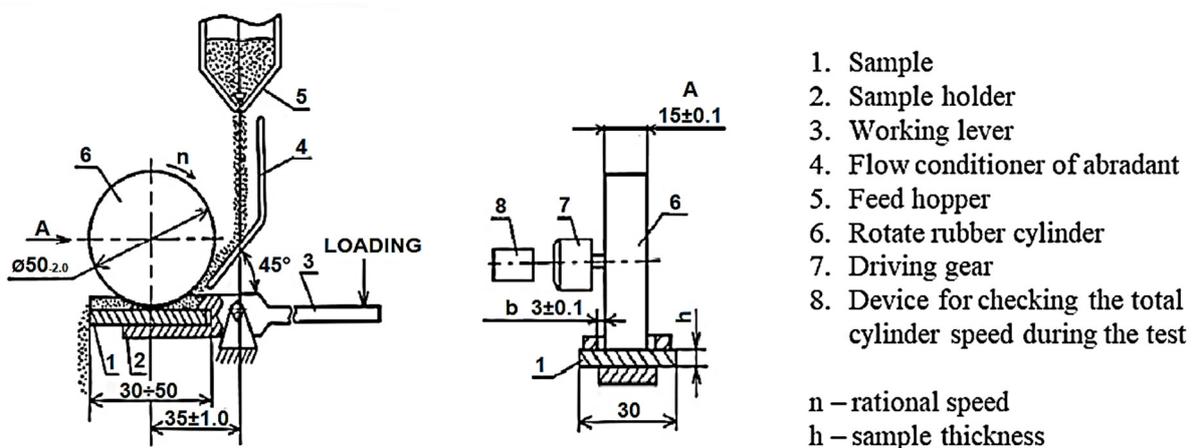
Before the test, each test body (standard, tested sample) is weighed and placed in the principle of the scheme of the test equipment for testing the abrasion resistance of the sample materials is shown in Figure 8. Each sample must be weighed on an accurate analytical balance before testing. Then the sample is placed in the holder of the testing equipment, the abrasive supply is started, and the rubber disc is pressed against the sample.

Figure 8. Scheme of the test equipment [26].

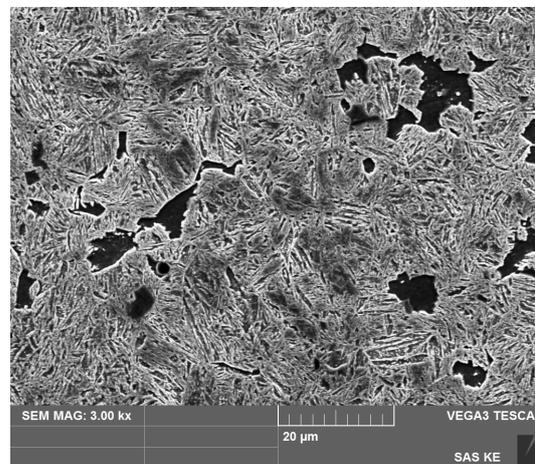
In Figure 9, we see the microstructure of the base material (BM). Cor etchant (120 mL  $\text{CH}_2\text{COOH}$ , 20 mL HCl, 3 g picric acid, 144 mL  $\text{CH}_3\text{OH}$ ) was used to induce the microstructure. The BM has a sorbitic microstructure—a mixture of ferrite and cementite. It is a ferritic-perlitic steel with a higher proportion of pearlite.

Figure 9. Microstructure BM–SEM.

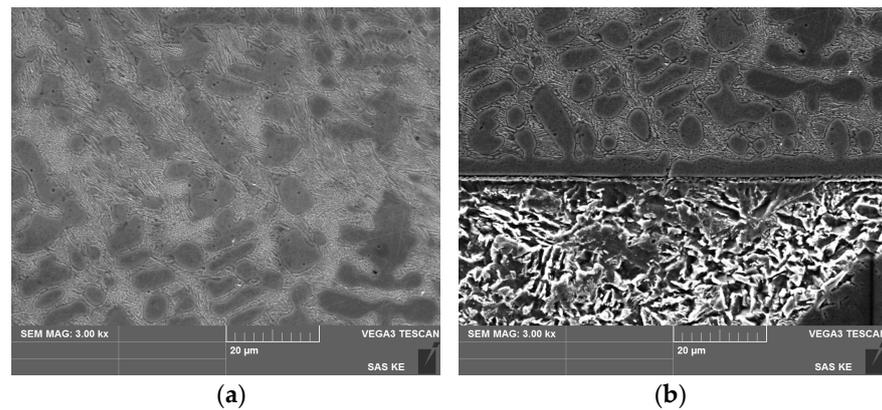
In Figure 10a, we see the hardfacing material of Samples 1. Cor etchant was used to develop the microstructure. We also see the mixing of the base material with the facing material (Figure 10b). The hardfacing material is mixed without voids, cracks and other defects that adversely affect the quality of the hard deposit cohesion. The hardfacing material has a dendritic microstructure. We can see that the microstructure of the BM has changed in the heat-affected zone (HAZ). We observe the presence of tempered martensite.

**Figure 10.** Microstructure of Sample 1: (a) hardfacing material; (b) interface hardfacing material-BM.

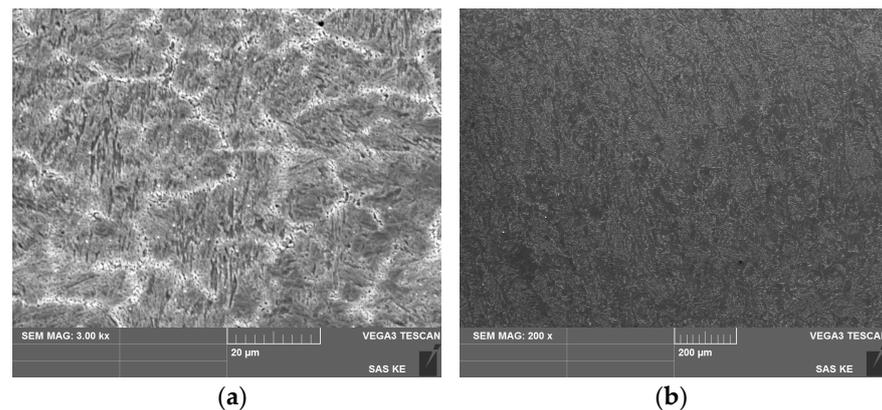
In Figure 11a, we see the microstructure of the hardfacing material of Sample 2. The sample was etched with a Cor etcher. The hardfacing material has a ledeburitic microstructure. It is identical to the microstructure stated by the manufacturer. In Figure 11b, we can see the interface hardfacing material-BM. The connection of the BM and the hardfacing material is without defects and without breaking the integrity of the hardfacing material and the BM.

**Figure 11.** Microstructure of Sample 2: (a) hardfacing material; (b) interface hardfacing material-BM.

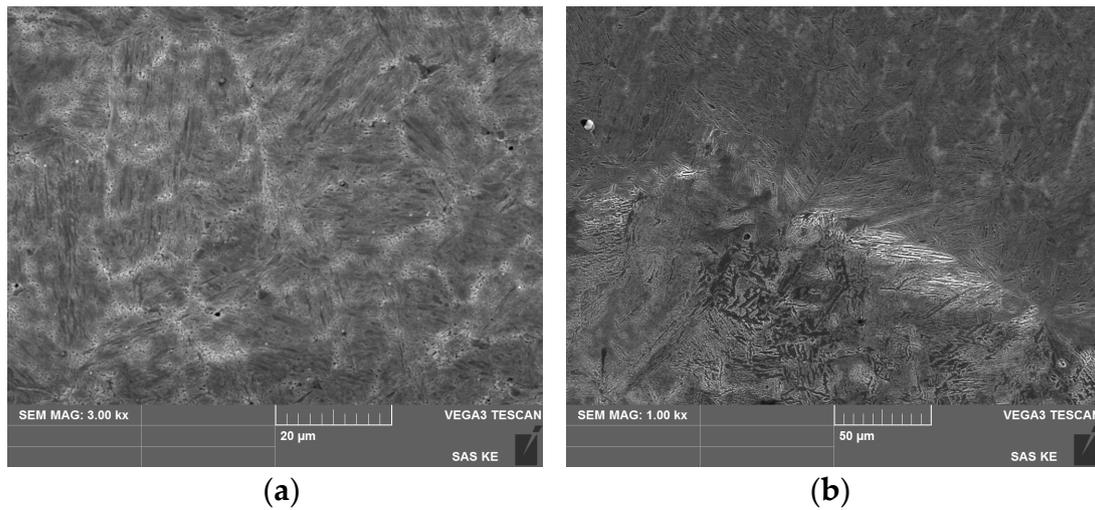
In Figure 12a, we see the microstructure of the hardfacing material of Sample 3. The sample was etched with 2% Nital (solution of  $\text{HNO}_3$  in ethyl alcohol). We observe the acicular needle-like structure of BM in the HAZ. In the HAZ, the presence of diffusion between the BM and the hardfacing material can be seen. We can conclude that there was a good mixing of the hardfacing material with BM (Figure 12b).

**Figure 12.** Microstructure of Sample 3: (a) hardfacing material; (b) interface hardfacing material-BM.

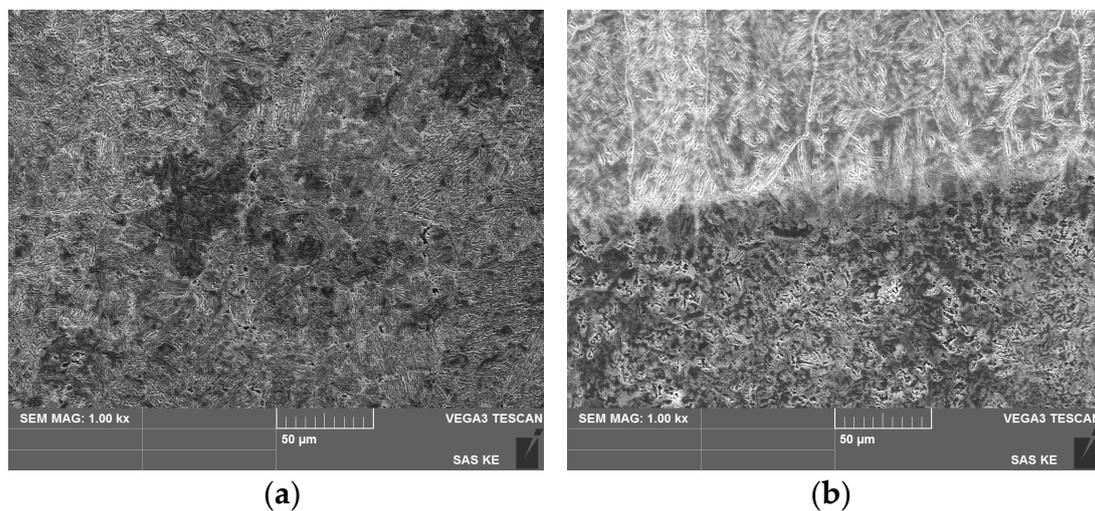
In Figure 13a, we see the microstructure of the hardfacing material of Sample 4. The sample was etched with a Cor etcher. We observe the polyhedral and acicular microstructure of BM in the HAZ (Figure 13b). We can see that the mixing of the hardfacing material with the BM of the tool is free of cracks, voids and other defects. There was a diffusion of chemical elements between the BM and the hardfacing material.

**Figure 13.** Microstructure of Sample 4: (a) hardfacing material; (b) interface hardfacing material-BM.

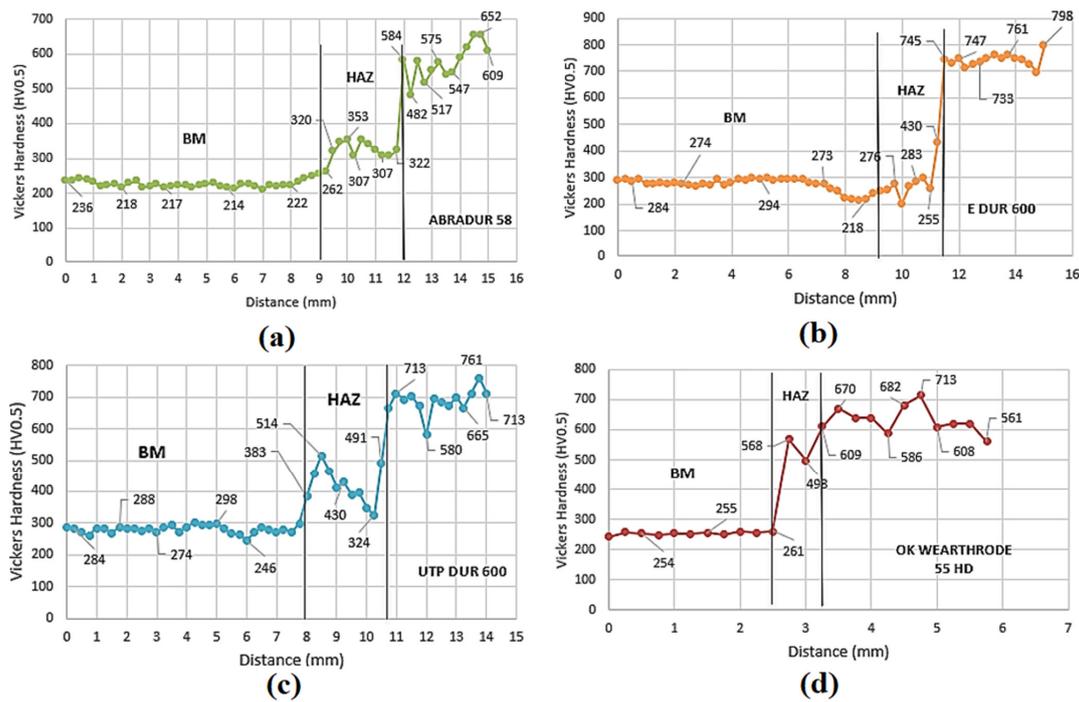
The indentations during measurement were guided from the core of the base material to the surface of the hardfacing material. The average hardness of BM, according to Vickers, was 285 HV0.5. The course of the measured hardnesses on Sample 1 is shown in Figure 14a. We can see that the thickness of the hardfacing material layer was about 3 mm. The hardness of the hardfacing material is significantly higher than the hardness of the base material of the working tool. The highest hardness value of the hardener was 652 HV0.5. The highest hardness value in the HAZ was 353 HV0.5.

**Figure 14.** Graphic representation of the course of hardness according to Vickers: (a) Sample 1; (b) Sample 2; (c) Sample 3; (d) Sample 4.

The course of the measured hardnesses of Sample 2 can be seen in Figure 14b. We can see that the hardfacing material also has significantly higher hardness values than the base material of the tool. The hardness of Sample 2 is higher than the hardness of Sample 1. The hardfacing material layer of Sample 2 is about 4 mm thick. The highest hardness value in the HAZ was 430 HV0.5.

The course of the measured hardnesses in Sample 3 can be seen in Figure 14c. The highest hardness of Sample 3 hardfacing material had a value of 761 HV0.5. The hardfacing material layer is approximately 3 mm thick. We can see that in the HAZ, the hardness values fluctuate considerably, which could have been caused by uneven mixing of the hardfacing material with the tool base material at the point of measurement or by the structure of the material in the HAZ. The highest hardness value in the HAZ was 491 HV0.5.

The greatest hardness of the hardfacing material on Sample 4 has a value of 713 HV0.5, and in the HAZ, it has a value of 568 HV0.5. The hardfacing material layer has a thickness of approximately 2.5 mm. The course of the measured hardnesses on Sample 4 can be seen in Figure 14d.

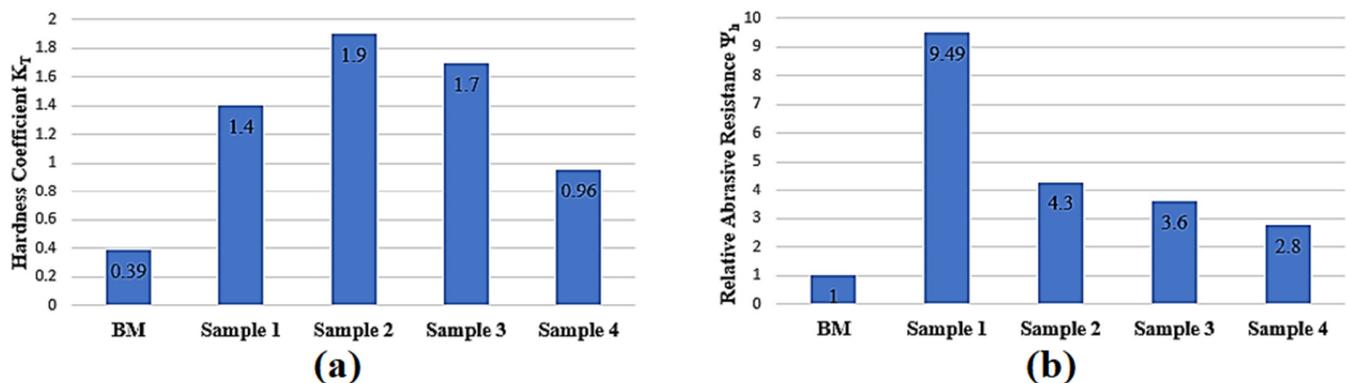
In Figure 15a, we can see a graphic representation of the  $K_T$  hardness coefficients for individual materials. If this value is higher than 1, it is assumed that the tested material will be able to better resist abrasive particles. We can state that the highest value of the hardness coefficient was achieved by Sample 2. At the same time, the lowest value of the  $K_T$  hardness coefficient was achieved by BM, namely, 0.39. In Figure 15b, we can see a graphical comparison of values of relative resistance to abrasive wear  $\Psi_h$ . It is clear from the graph that Sample 1 achieved the best relative resistance to abrasive wear. It is almost 9.5 times more compared to the BM of the tool. Sample 4 achieved the smallest value of relative resistance to abrasive wear, namely, 2.8. However, it is 2.8 times more compared to the BM of the tool. We can conclude that all the tested hardfacing materials achieved several times better resistance to abrasive wear compared to the BM of the tool.

**Figure 15.** Graphic representation of the values from the abrasion resistance test: (a) hardness coefficient  $K_T$ ; (b) relative abrasive resistance  $\Psi_h$ .

Some authors report that hardness is strongly correlated with resistance to abrasive wear [30–32]. However, based on the results of the hardness measurement and the test of resistance to abrasive wear, we can conclude that the hardfacing material with the highest hardness value (59HRC) achieved a lower value of relative abrasion resistance compared to the hardfacing material with lower hardness (56HRC). The hardfacing material with lower hardness achieved a 2.36 times higher value of relative resistance to abrasive wear. In the results of their research, the authors [18] also state that hardness is correlated with resistance to abrasive wear. However, from the partial results, it can be concluded that the W-rich alloy reached a lower value of resistance to abrasive wear compared to the Cr-rich hardfacing material, even though its hardness was higher than that of the Cr-rich hardfacing material.
