# Construction Failures and Innovative Retrofitting

Nicola Augenti <sup>1</sup>, Antonio Nanni <sup>1,2,\*</sup> and Fulvio Parisi <sup>1</sup>

**Abstract:** The aim of this paper is twofold: (a) to briefly describe the damage caused to historical, residential and industrial buildings by the May 2012 seismic events in the Emilia Romagna region of Italy; and (b) to summarize novel repair and rehabilitation technologies that can be available to practitioners to fix damaged structures or to upgrade undamaged ones. Field inspections after the Emilia Romagna earthquakes showed that seismic vulnerability in that region was primarily due to the lack of seismic detailing in modern buildings, and the presence of heavy nonstructural masses in historical buildings. The novel retrofit technologies discussed in this paper are based on the use of non-conventional or relatively recent material systems where the reinforcement is in the form of continuous or chopped fibers.

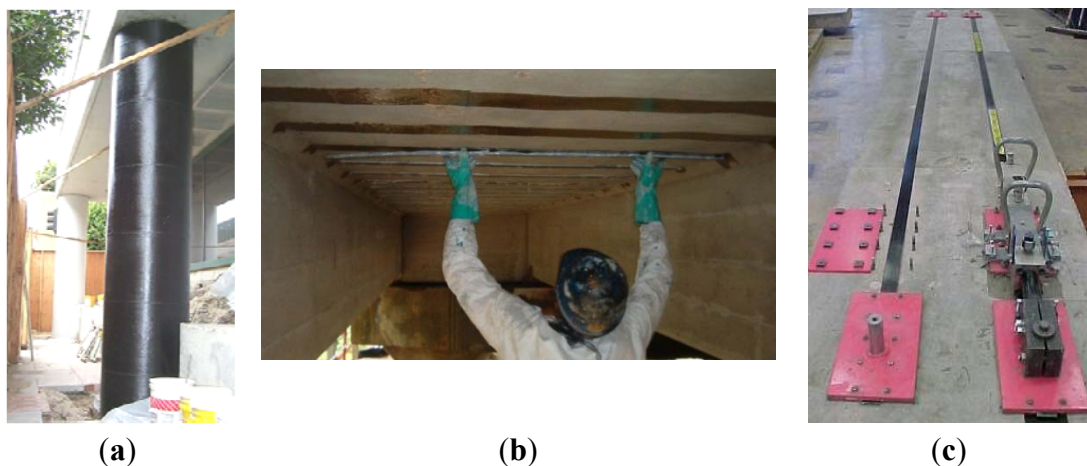
**Figure 24.** Externally bonded Fiber-reinforced polymer (FRP) installations: (a) Manual lay-up for column confinement; (b) Bonded plate for flexural upgrade; (c) Plate pre-tensioning system.

The last two decades have seen the coming of age of composite materials (also known as fiber-reinforced polymer or FRP composites) for the retrofitting of existing structures [14,15]. Italy has been at the forefront in the adoption of the FRP technology from both the practical point of view (*i.e.*, wide variety and number of applications) as well as its inclusion in design and construction specifications [16]. FRP technologies include externally bonded fiber sheets installed by manual lay-up and pultruded FRP plates, adhesively bonded. The former method can provide shear and flexural strengthening in addition to column confinement (Figure 24a), whereas the latter method is primarily used for flexural strengthening (Figure 24b). Pre-tensioning of the FRP prior to bonding has been attempted to increase the efficiency of the strengthening of FRP (Figure 24c), however, commercially available systems have not yet completely overcome the challenges presented by anchoring and installation.

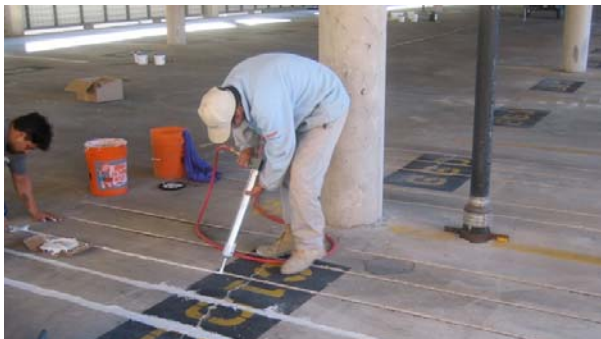
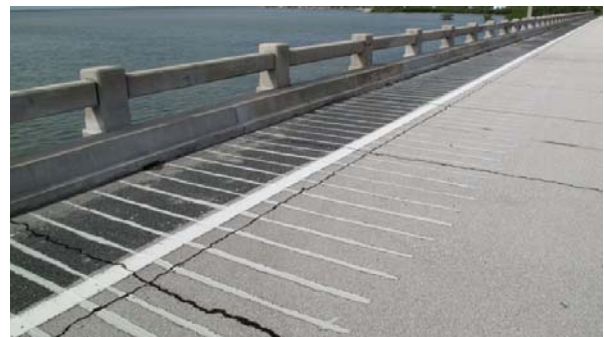
**Figure 25.** Near-surface-mounted (NSM) FRP installation on negative moment regions: (a) Exposed concrete slab in a parking garage; (b) Concrete below the asphalt overlay in the cantilevered portion of a bridge deck.

The FRP technology, known as near-surface-mounted (NSM), FRP reinforcement (in the case of concrete and timber members), or structural repointing (in the case of masonry), is perhaps less known and utilized, even though it may have an aesthetic advantage over externally bonded FRP systems. In the case of concrete strengthening, an FRP bar is embedded in a pre-cut groove then filled with an epoxy resin (Figure 25), whereas in the case of in-plane or out-of-plane masonry wall strengthening, the existing mortar in the bedding joint is typically removed, the FRP bar is inserted between masonry units, and the cavity is filled with resin or mortar depending on the type of application and its design requirements (Figure 26).

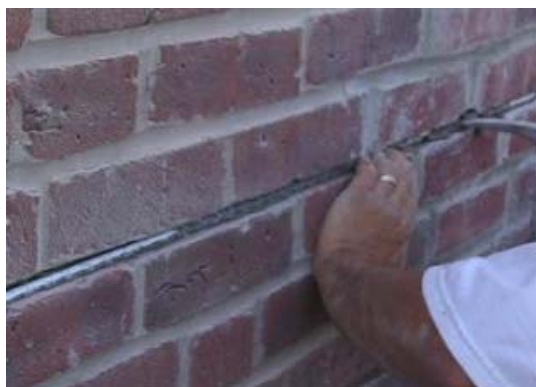
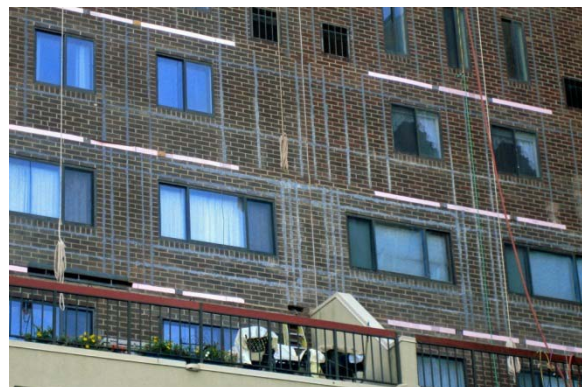
**Figure 26.** Structural FRP repointing in clay masonry walls: (a) Installation of an individual bar in an open joint; (b) View of the façade after completion of the repointing.

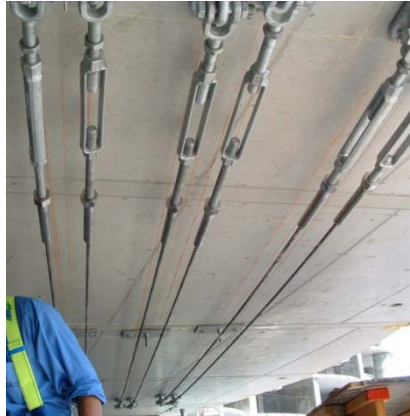
**Figure 27.** External post-tensioning with carbon FRP tendons.

Successful application of FRP bars for external post-tensioning has also been implemented (Figure 27) even though the complexity of developing efficient and inexpensive anchors acts as a deterrent to extensive deployment as for the case of pre-tensioning of externally bonded FRP.

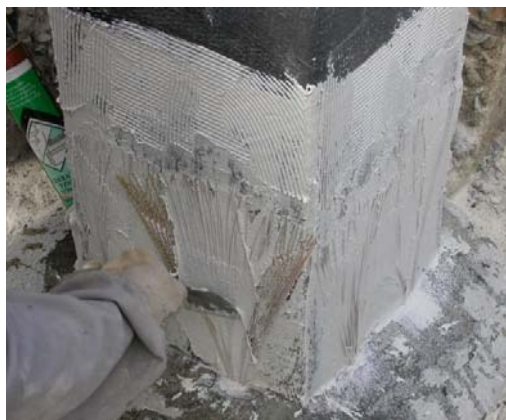
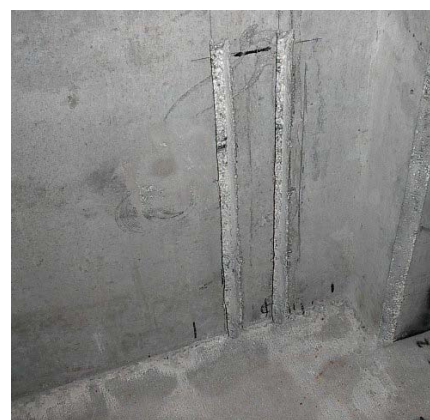
**Figure 28.** Reinforcement continuity at column/wall to footing connection: (a) FRP nail; (b) NSM FRP bar.

An FRP nail is a fiber strand that is fully pre-impregnated with resin and cured for approximately half of its length, with the other half left dry (not impregnated). The cured (rigid) portion of the nail is then inserted in a predrilled hole filled with additional fresh resin, while the dry fibers are opened up in a fan-like fashion and bonded to the substrate similarly to manual lay-up (Figure 28a). FRP nails have been successfully used to create reinforcement continuity at connecting members and also to improve the anchorage of externally bonded sheet. Similarly, NSM FRP bars have been successfully used to create continuity and bending moment transfer in particular (Figure 28b). For the case shown in the figure, a quasi-vertical hole is drilled into the foundation while the concrete wall is grooved so that, after installation, the FRP bar is fully encased.

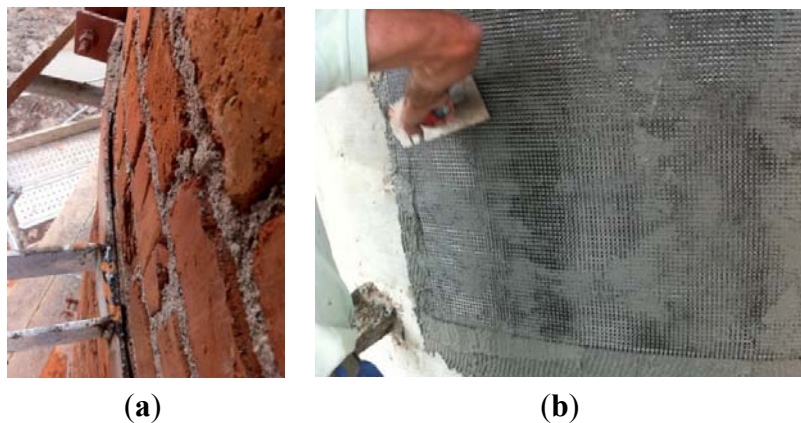
**Figure 29.** Masonry surface: (a) Before; and (b) during strengthening.

The challenge and appeal of FRCM systems is in the use of a matrix that is more compatible with the concrete or masonry substrate, but is at the same time brittle and with a strain to failure much lower than that of the fabric reinforcement. From an innovation standpoint, the commercial availability of nano-materials as modifiers of the mortar matrix is the new research frontier. Of particular interest is the use of FRCM to strengthen masonry structures [19,20] (Figure 29).

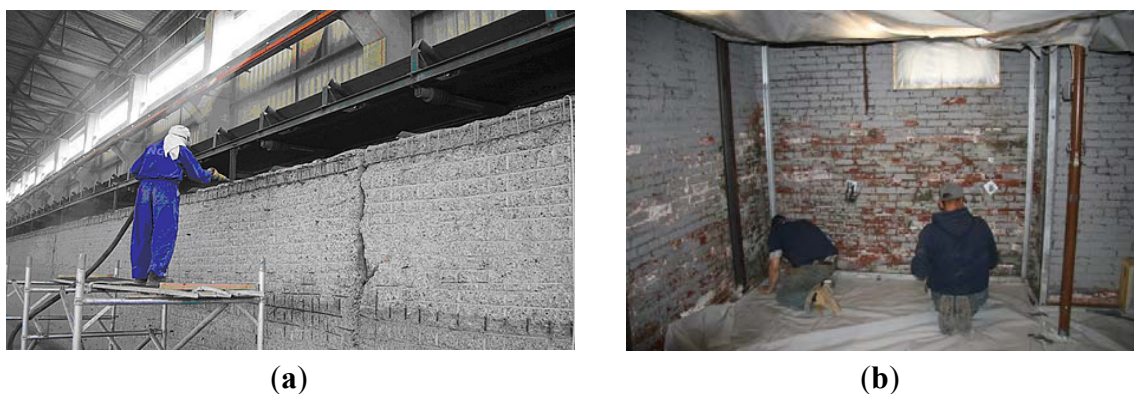
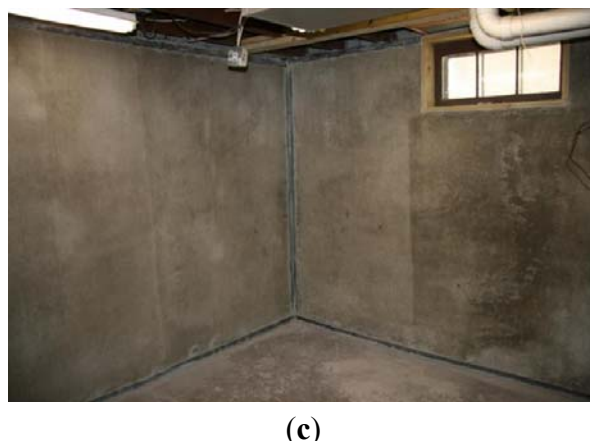
**Figure 30.** Shotcrete repair: (a) Concrete wall in a factory; (b) Clay masonry walls in a basement before repair; (c) After repair.

Randomly distributed fibers can be added to a mortar or concrete to create what is known as FRC (fiber-reinforced concrete). This is the oldest and most investigated among the composite technologies for construction. It has proven very effective in applications such as slabs-on-grade and tunnel linings, but new developments make it particularly attractive, and viable, for the repair and rehabilitation of concrete or masonry when the delivery method is shotcrete. FRC shotcrete may be a superior technology if the substrate surface, after removal of loose or deteriorate portions, is particularly rough such as in the case when the reinforcement is fully exposed (Figure 30a). Another suitable application is in the case of basement walls, either constructed with inadequate building materials such as stone or rubble, or that have suffered extensive damage (Figure 30b,c).
