Variation in Water Quality in an Impacted Coastal Lagoon over the Last Decade (Küçükçekmece Lagoon, Turkey) [†]

[†] Presented at the 7th International Electronic Conference on Water Sciences, 15–30 March 2023;

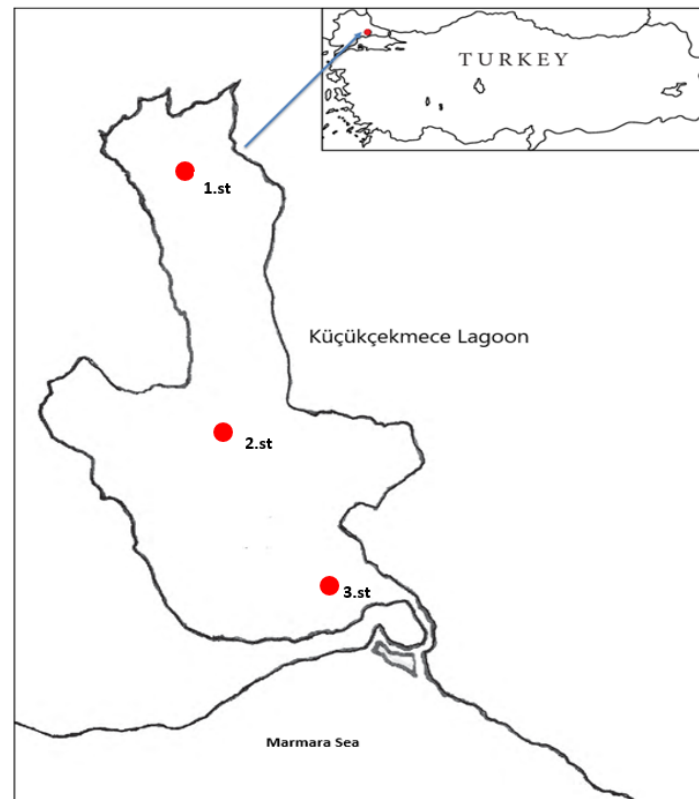
Figure 1. Location of sampling sites in Küçükçekmece Lagoon.

Küçükçekmece Lagoon is located in the south-west of Istanbul (Figure 1). It has a direct connection to the Marmara Sea with a canal. It has a 15.22 km² surface area and a maximum depth of 18.5 m. Because of rapid urbanization and industrialization, a significant deterioration in water quality was observed due to intense wastewater discharge.

To compare water quality variations, samples were collected from June to December 2012 and 2022 at regular monthly intervals. Water samples were collected from the surface in two stations (first and third station), and to observe the depth profile, the samples were collected throughout the water column (surface, 9 m, and 18 m) from the second station. Dissolved oxygen (DO), salinity, and temperature were measured in situ using the YSI multiparameter instrument (YSI 650 MDS). Chlorophyll-*a* (chl-*a*) was determined using the method of ISO 10260 (1992) [7]. Nutrient analyses for nitrite (NO₂), nitrate (NO₃), total phosphorus (TP), and silicate were performed according to APHA-AWWA WPCF (1989) [8].

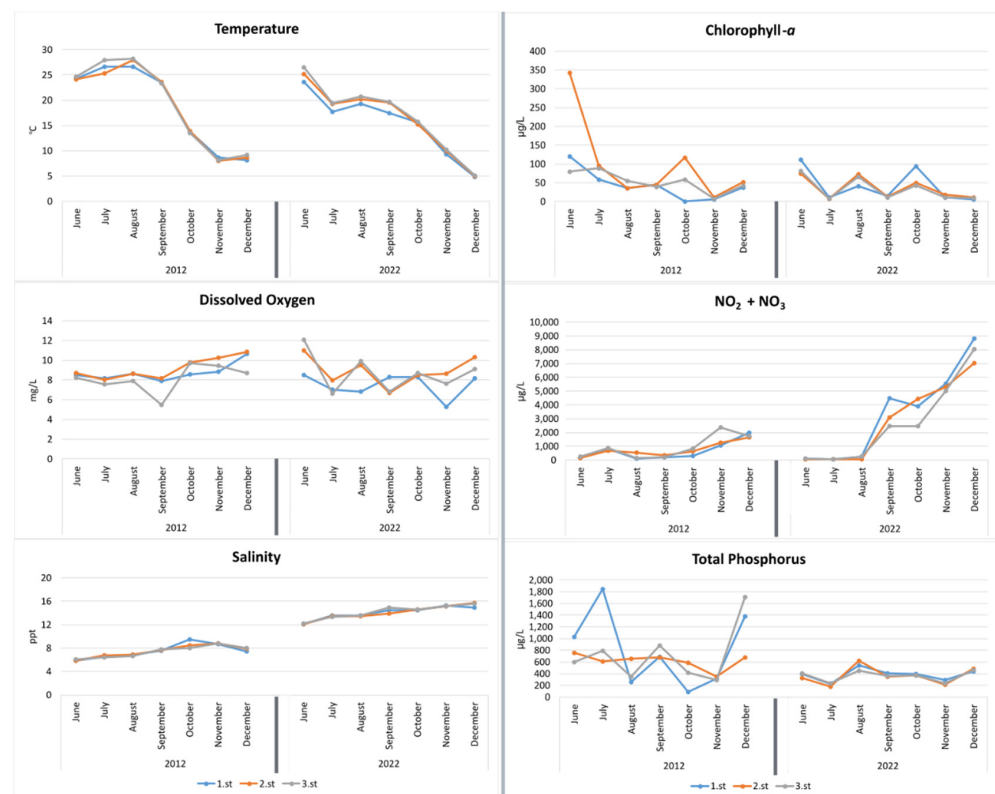
Figure 2. Physicochemical characteristics of surface waters of stations.

The physicochemical characteristics of the surface waters of Küçükçekmece Lagoon are given in Figure 2. The water temperature ranged between 8.1 and 28.2 °C. The salinity diagrams (Figures 2 and 3) showed that seawater inflow influences the lagoon's characteristics. It was determined that the salinity level doubled from 2012 (mean: 7.44 ppt) to 2022 (mean: 14.1 ppt). Due to the increase in salinity, the detected cyanobacteria members between 1990 and 2015 were left to marine species instead. This revealed that chl-*a* decreased in 2022. While the mean value of total phosphorus concentration was 712.1 µg/L in 2012, it was measured as 370 µg/L in 2022. The mean value of nitrate and nitrite concentrations increased from 0.72 mg/L to 2.9 mg/L in 2022. All these measurements showed that the trophic status of Küçükçekmece Lagoon was hypertrophic since the 1990s and did not show any sign of enhancement.

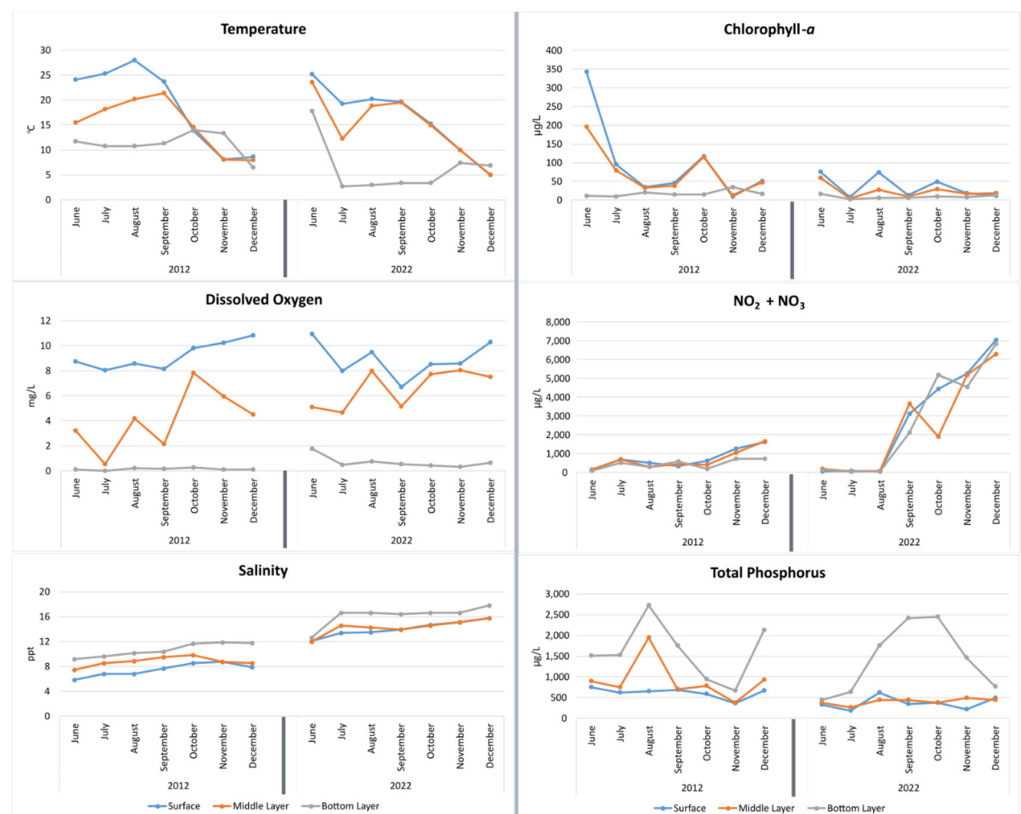
Figure 3. Depth profile of physicochemical characteristics of station 2.

In the water column, data showed that as a result of thermal stratification, the water quality deteriorated at the bottom of the lake because of slow water exchange between layers [9]. As an important indicator of trophic status, oxygen concentration or depletion rates in hypolimnetic water have long been studied [10]. In all sampling periods, the bottom layer was characterized by anoxic conditions (Figure 3). Gürevin et al. reported that the significant release of nutrients from sediment caused long-term eutrophication in the lagoon [11].
